Boston City Hall

Conservation Management Plan

January 2021

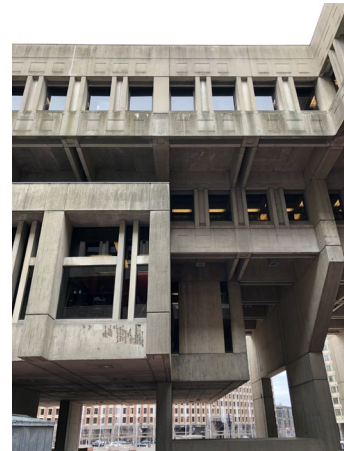
Spalling and organic staining.

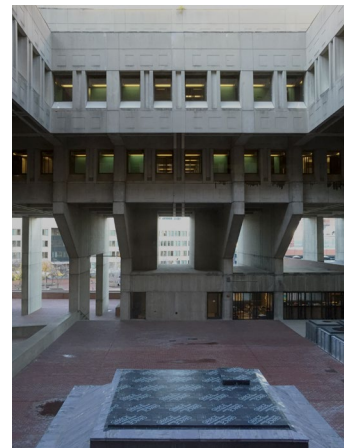
Waterproofing membrane covering central skylight and metal panels under upper-floor windows.

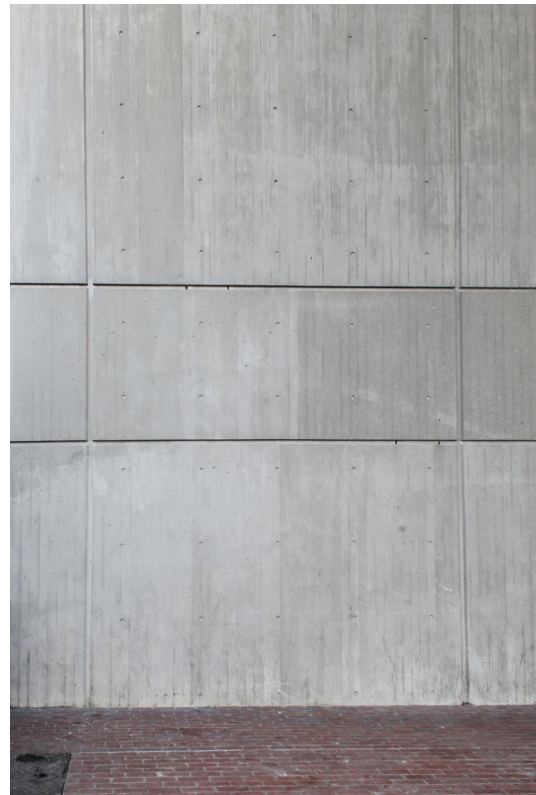
Sample of wall with filled form tie holes at the columns and partially filled tie holes in the field (January 11, 2021).

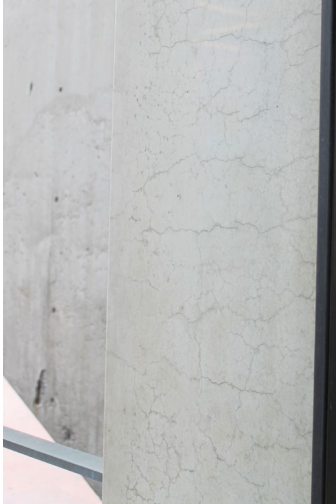
Top: Crazing located outside of council chamber at fire stair balcony (March 29, 2018).

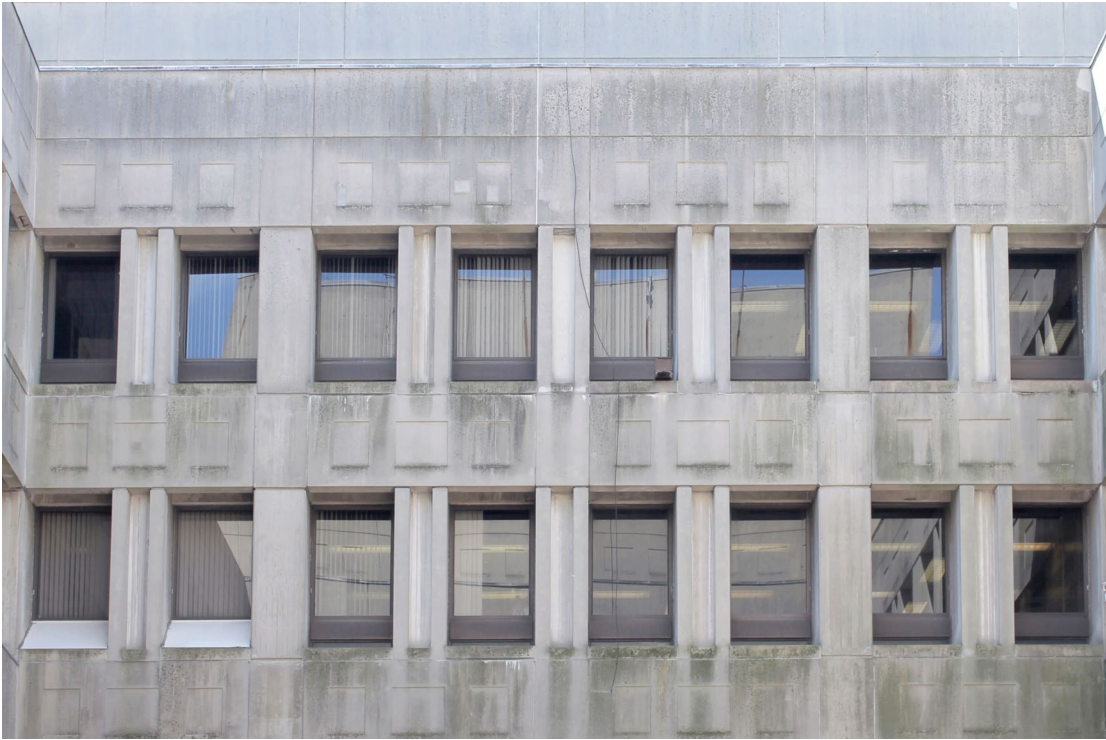
Courtyard at sixth and seventh floors, north-facing facade—representative soiling conditions on precast concrete sections (May 23, 2018).

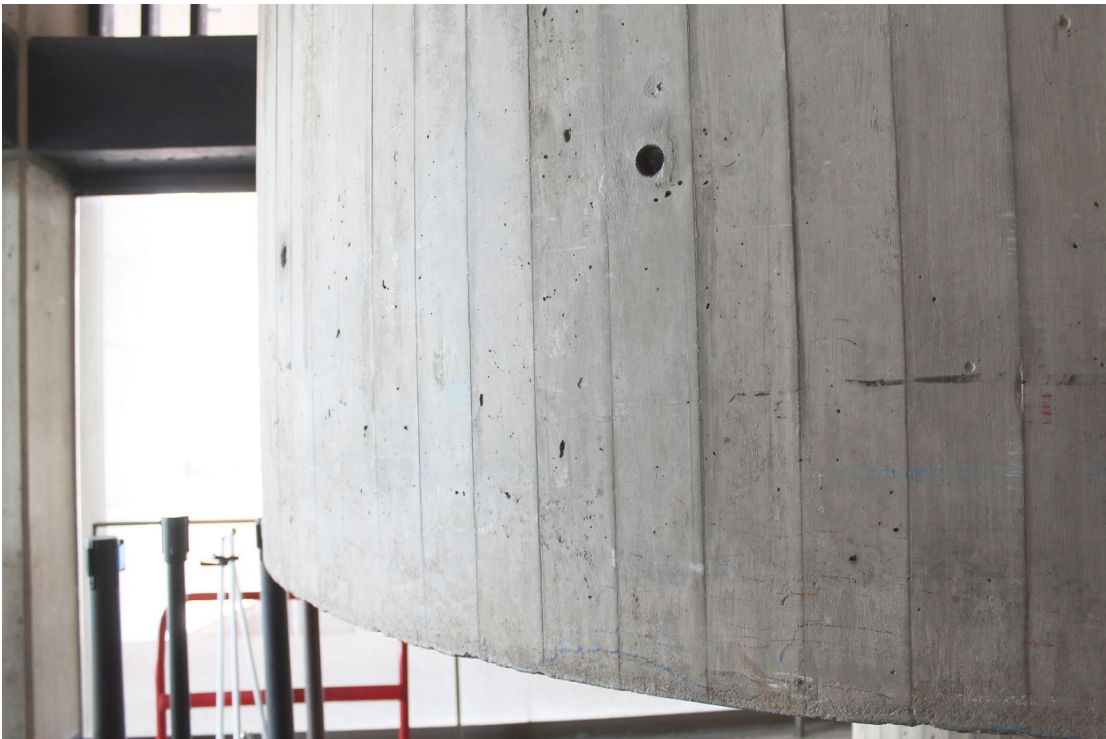
General conditions of interior concrete, shown at the mayor's stair (June 21, 2018).

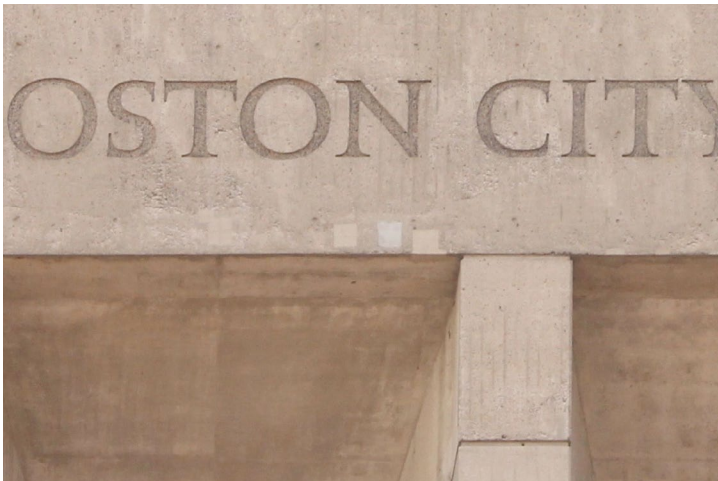
Example of poorly matched patches.

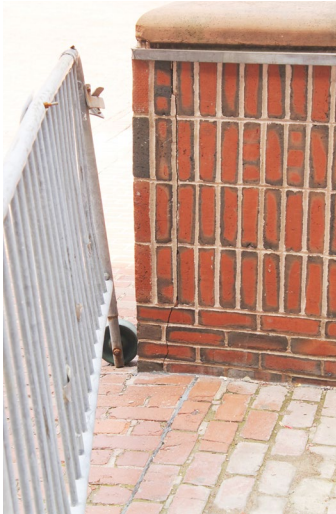
Top: Displacement cracking (May 23, 2018).

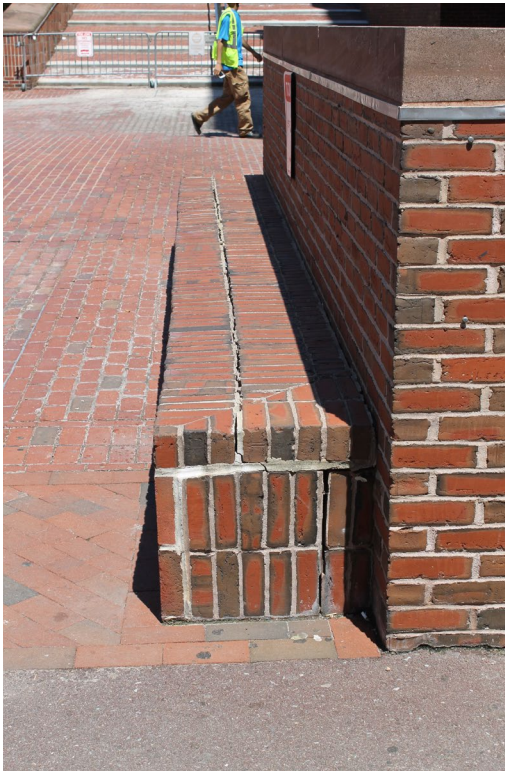
Top: General masonry failure adjacent to accessible ramp to the west entry (May 23, 2018).

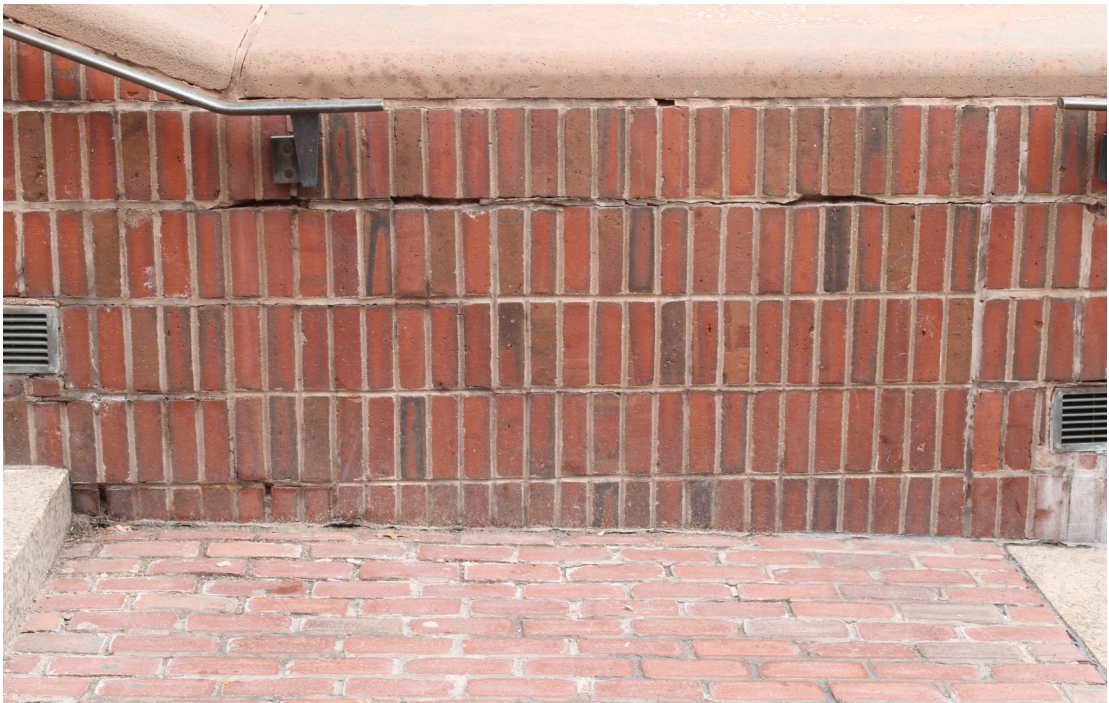
Failed mortar joints (January 11, 2021).

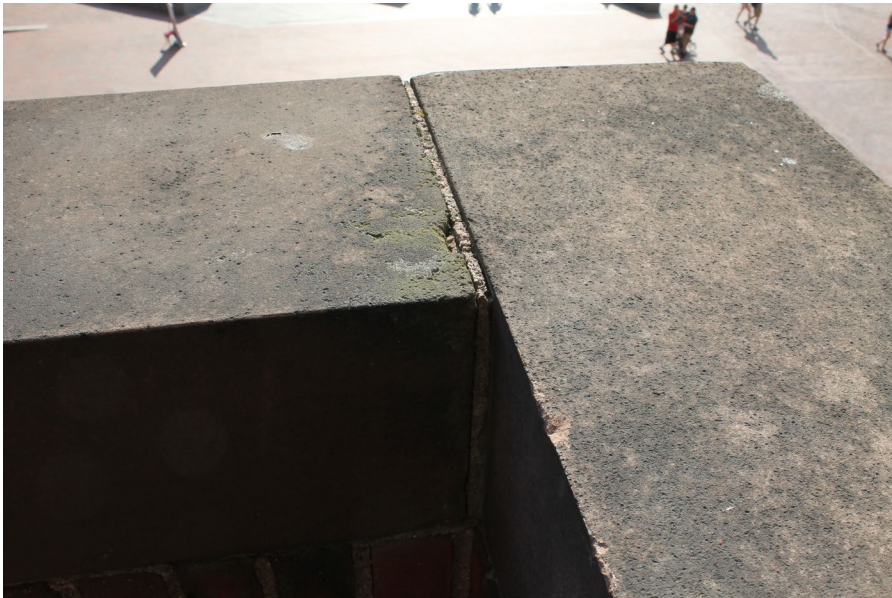
Brownstone with cementitious mortar joint (June 21, 2018).

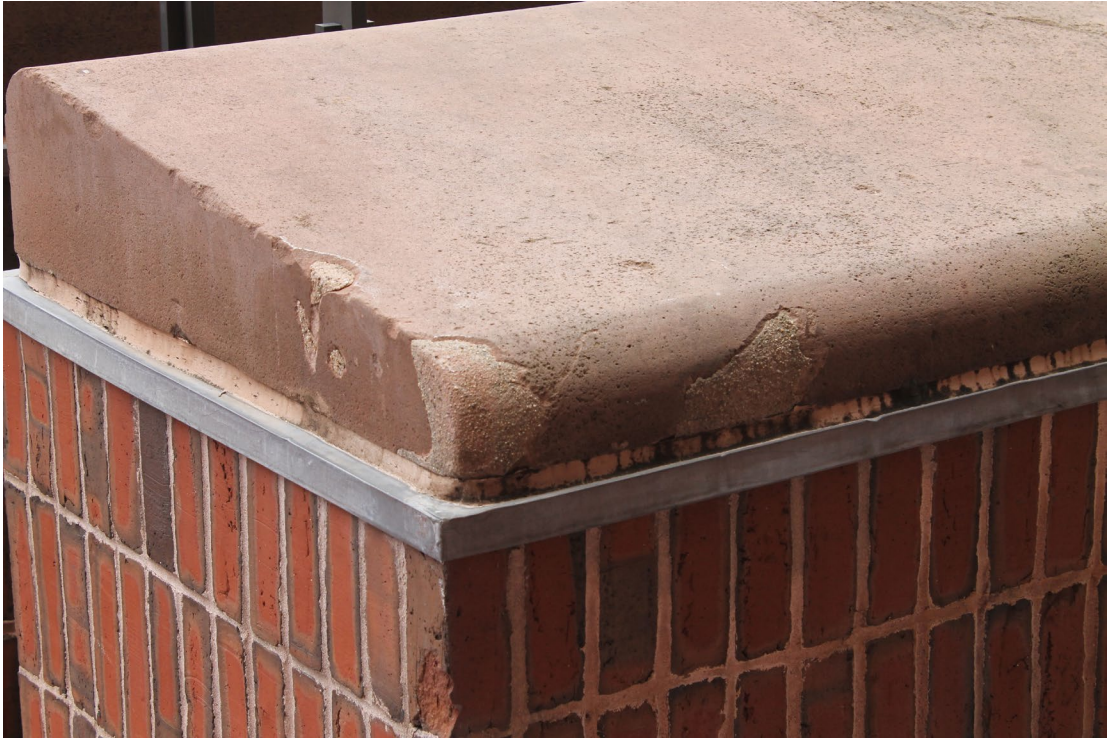
Poorly matched brownstone repairs and through-wall flashing detail (May 23, 2018).

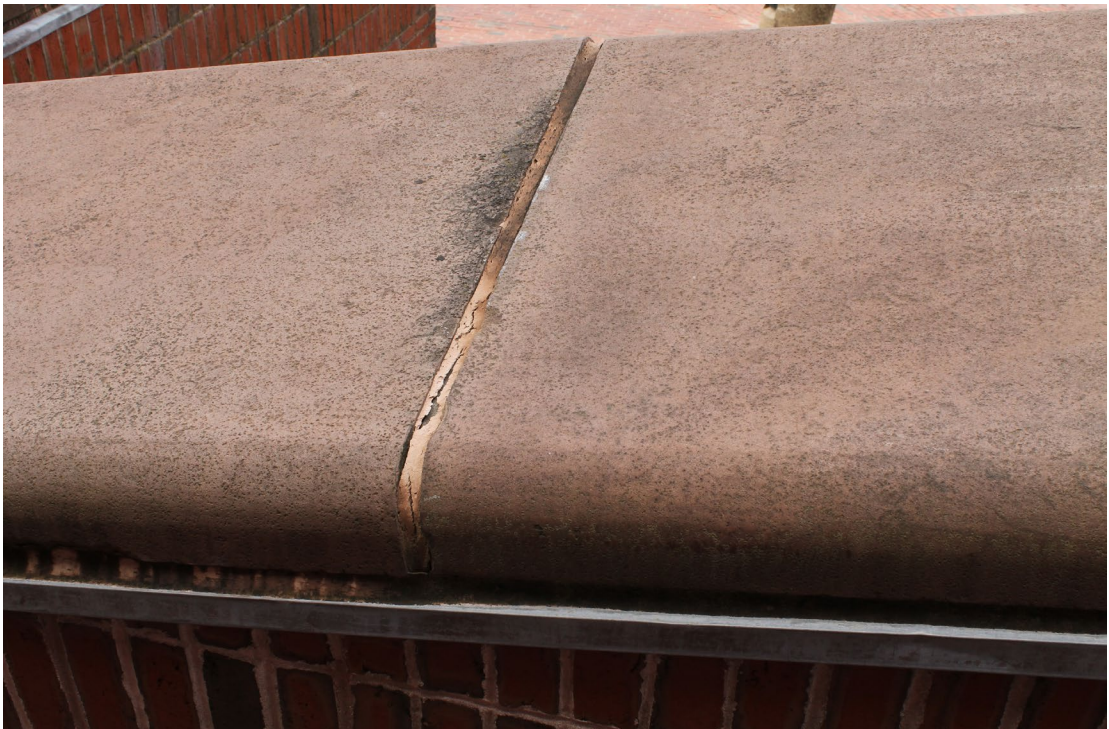
Brownstone with sealant mortar joint (May 23, 2018).

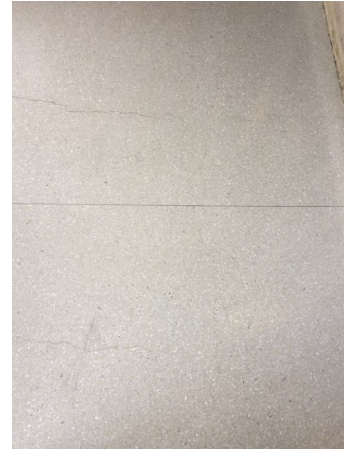
Top: Typical cracking of terrazzo flooring (June 13, 2018).

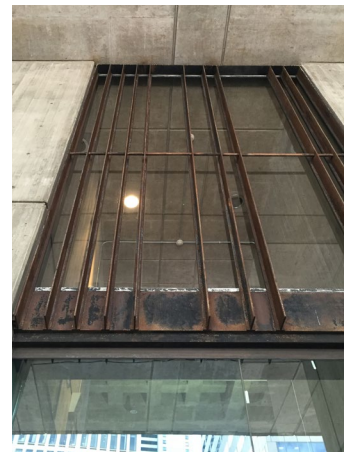
Rust development at steel window mullions on the south elevation (May 16, 2016).

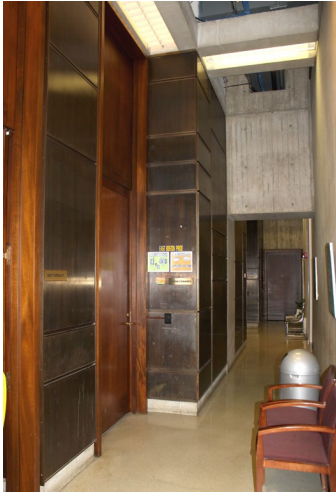
Typical bronze paneling conditions, city council corridor (June 21, 2018).
