RE: Northern Avenue Bridge Replacement Project

Project Name: Northern Avenue Bridge Replacement Project		
Street Address: Northern Avenue Bridge		
Municipality: Boston	Watershed: Boston Harbor	
Universal Transverse Mercator Coordinates: 331212.55 E 4691169.61 N, Zone 19T	Latitude: 42.354484° N	Longitude: -71.049435° W
Estimated commencement date: 01/2020	Estimated completion date: 2022	
Project Type: Bridge Replacement	Status of project design: 25 %complete	
Proponent: City of Boston Public Works Department		
Street Address: Boston City Hall, One City Hall Square, Room 710		
Municipality: Boston	State: MA	Zip Code: 02110
Name of Contact Person: Para Jayasinghe		
Firm/Agency: Boston Public Works Department	Street Address: 1 City Hall Square, Room 710	
Municipality: Boston	State: MA	Zip Code: 02110
Phone: (617) 635-4968	Fax:	E-mail: para.jayasinghe@boston.gov

Attachment 1 – Figures (USGS Map, Aerial Photo, FEMA Map)
Attachment 2 – Plans (25% Design)
Attachment 3 – ENF Distribution List
Attachment 4 – Permit List
Attachment 5 – Previous Correspondence with MHC
Attachment 6 – Substructure Inspection Report
Attachment 7 – Existing Condition Report

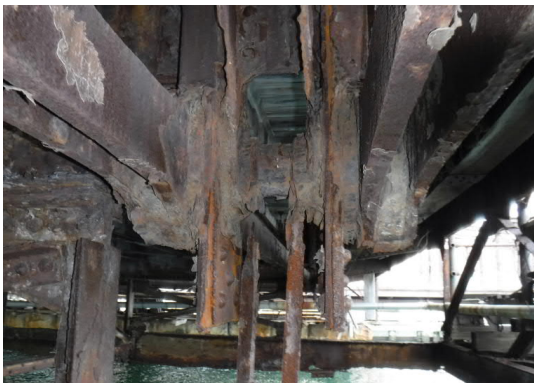
Image 5: Severe Deterioration of the Verticals Below the Deck and Pin

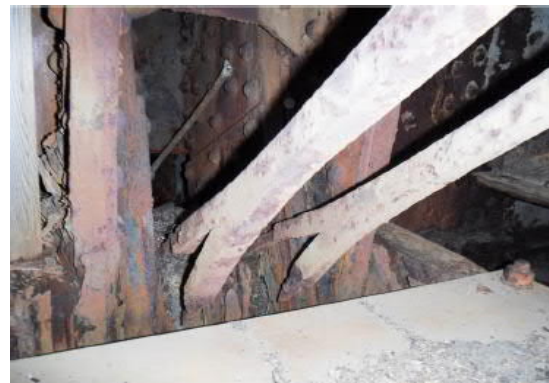
Image 6: 100% Section Loss of Eye Bars Diagonals in the Swing Span

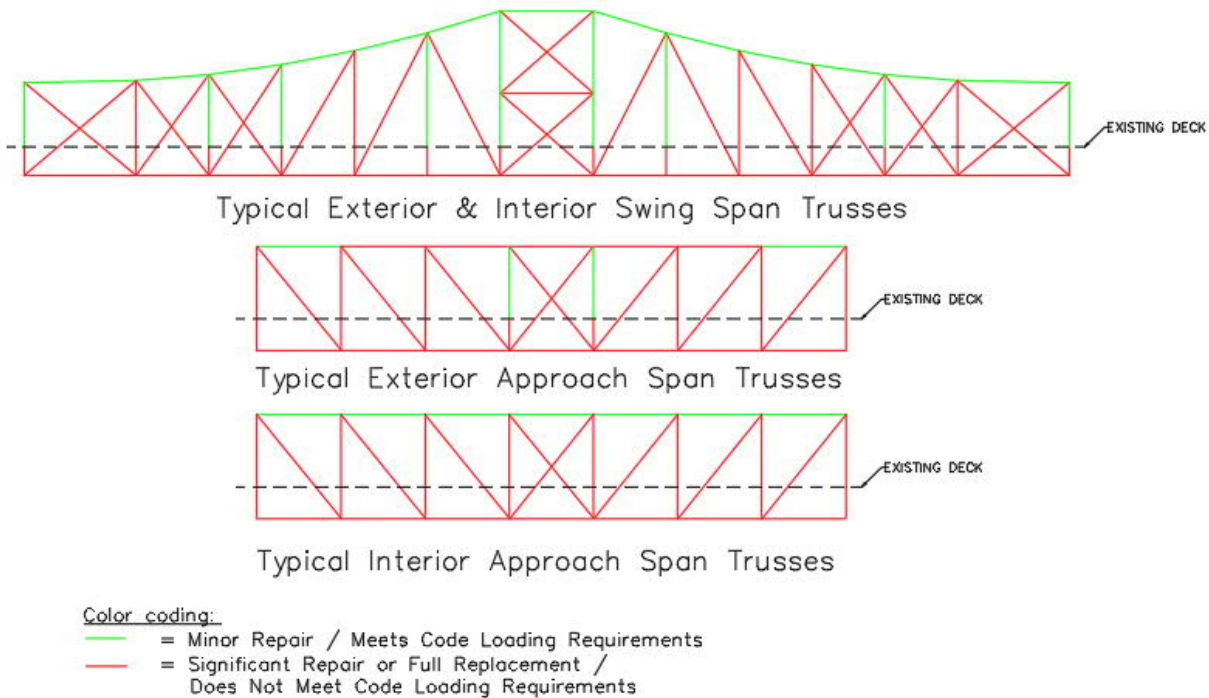
Combining the results of the condition inspection and structural analysis, the elements of the bridge which may be potentially re-used in a rehabilitated structure have been evaluated. As previously discussed, the floor system is beyond repair and would require replacement in any rehabilitation scenario. Figure 1 below graphically shows the summary of the results of the combined capacity and condition analysis for the primary truss elements. The elements depicted in red indicate members which would need significant repair and/or do not meet current load capacity requirements. Members depicted in green would meet current load capacity requirements but may also require minor repairs. The diagram is shown for a typical truss in the structure; there is some minor variation among the spans and trusses. Overall, based on existing conditions and structural analysis, 75% of the exterior and interior swing span trusses, 90% of the exterior approach span trusses and 75% of the interior approach span trusses primary members would require significant repair and/or do not meet load capacity requirements. For the secondary truss elements approximately 25% of the upper sway bracing on the approach spans and less than 20% of the upper sway bracing on the swing span would require significant repair and/or do not meet load capacity requirements.

Figure 1: Truss Based on Combined Condition and Capacity

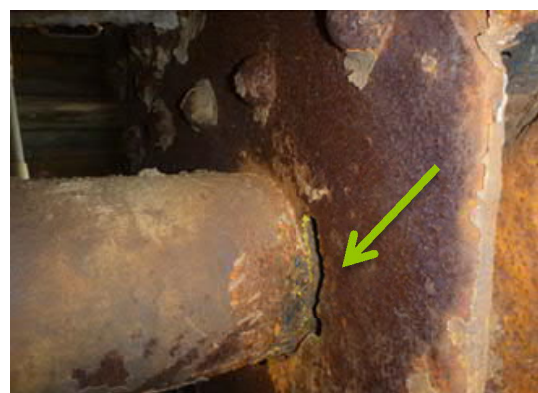
Image 11: Egging around the Pin Hole

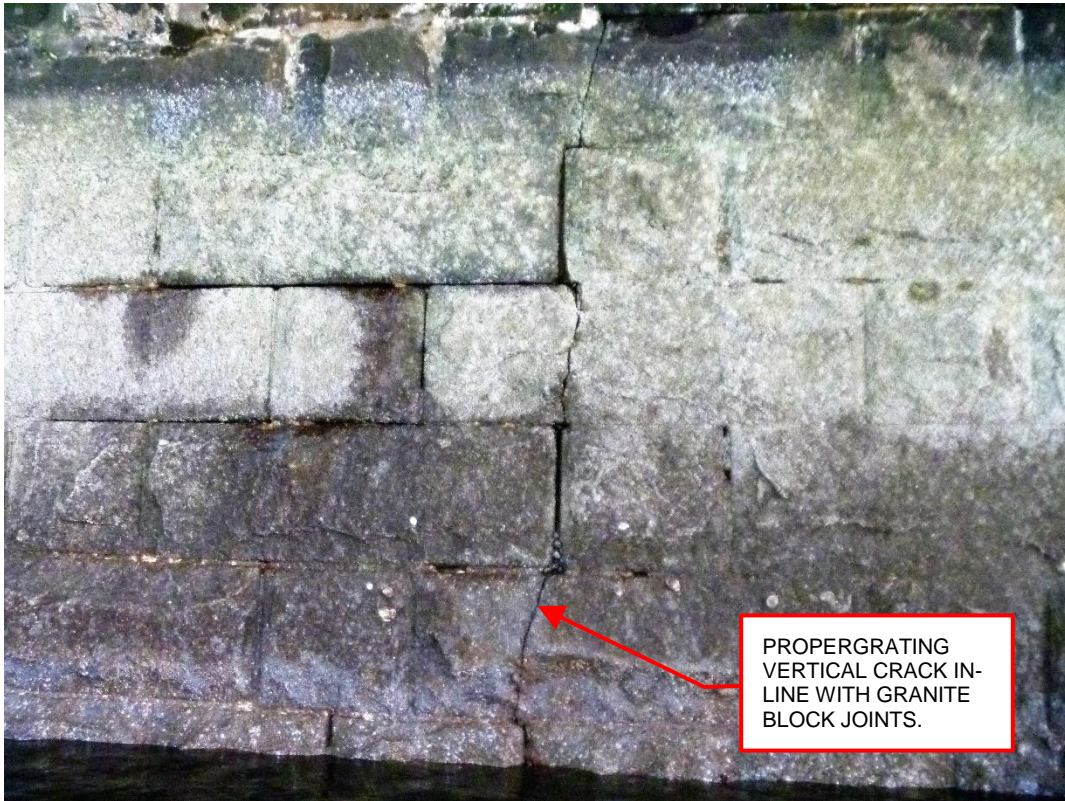
Photo 9 – Vertical crack in granite blocks in the Boston Abutment.

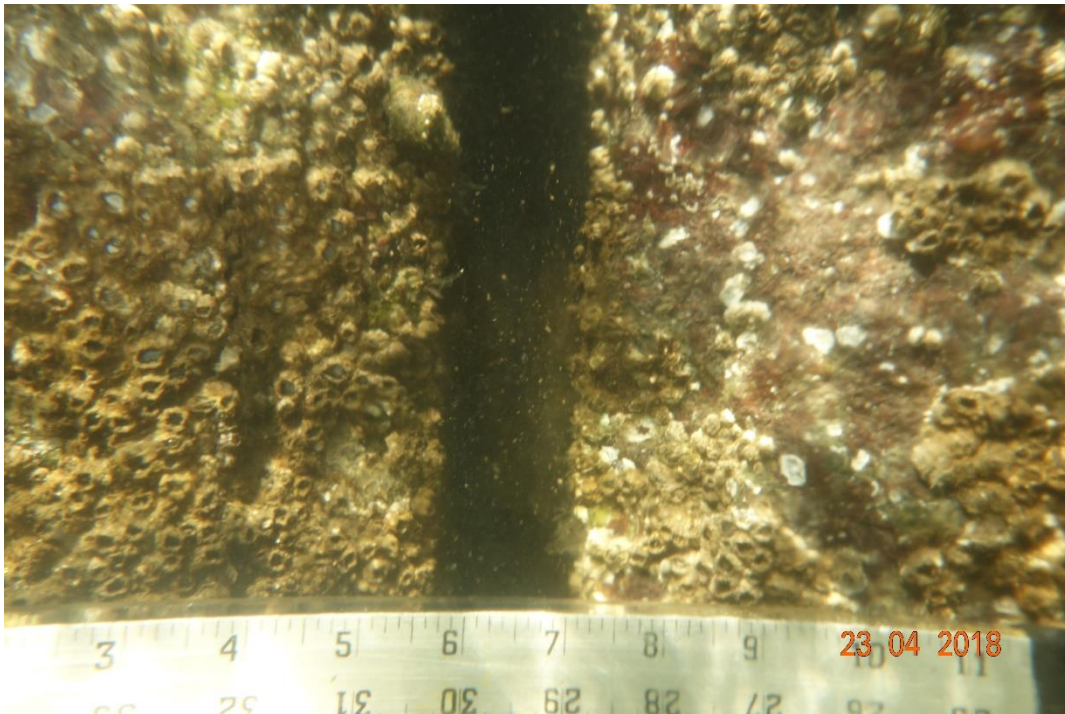
Photo 10 – Typical gaps, with mortar loss, in granite blocks below water.

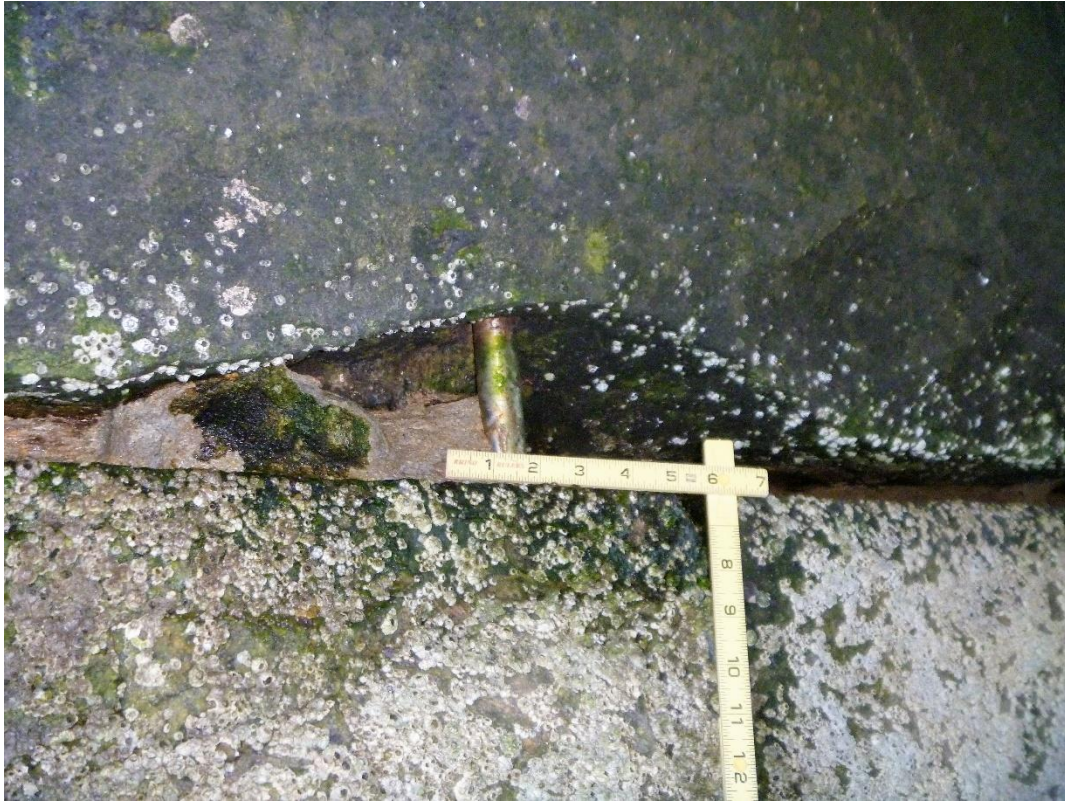
Photo 11 – Exposed stainless steel tie rod in granite block of Pier 2's East face.

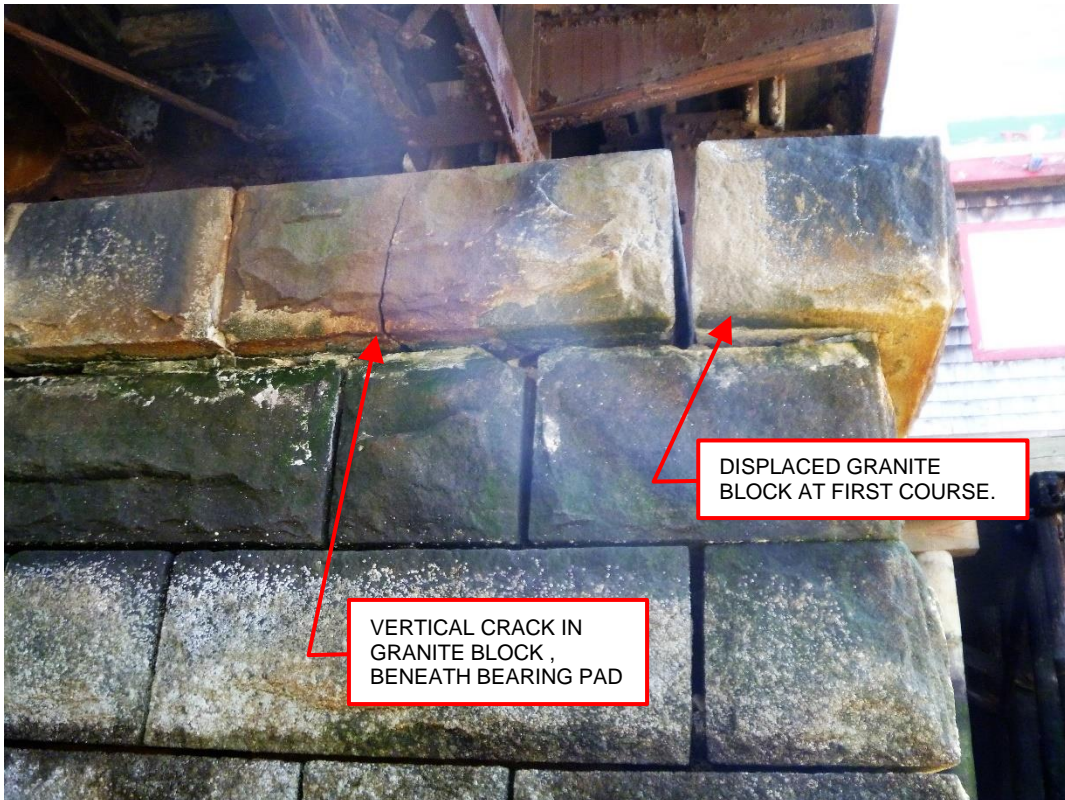
Photo 12 – Vertical crack in granite block, and displaced granite block.

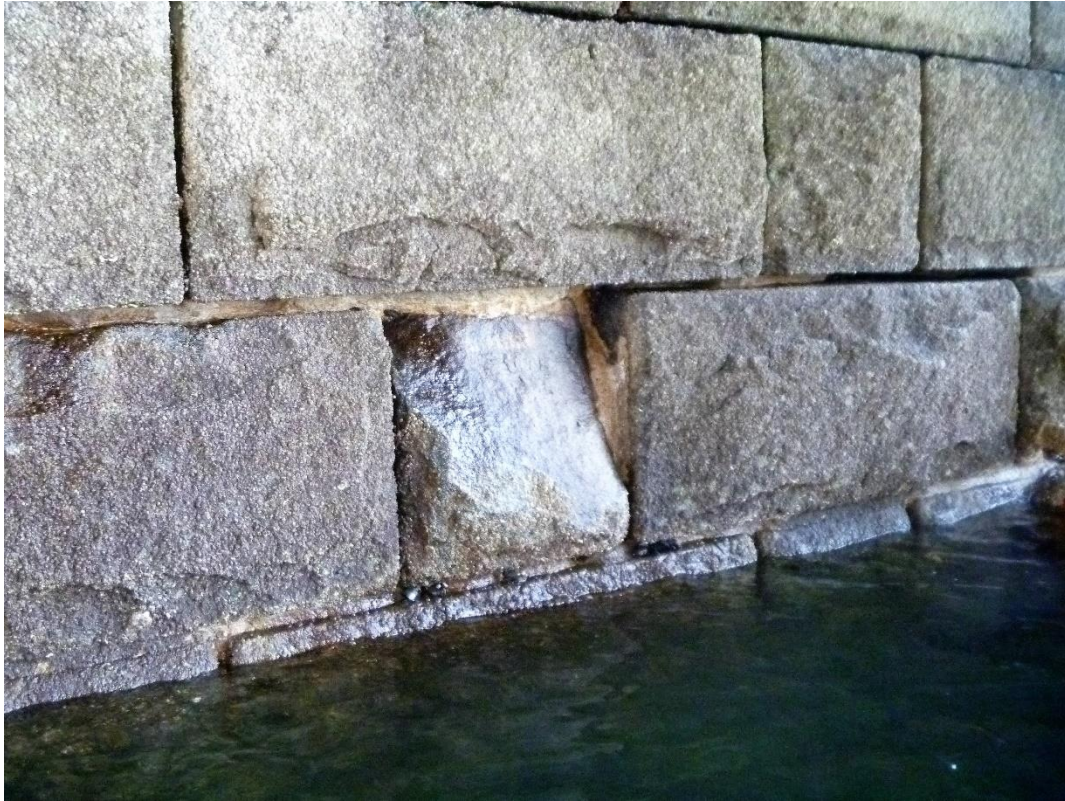
Photo 13 – Cleaved corner of granite block in Pier lower course.

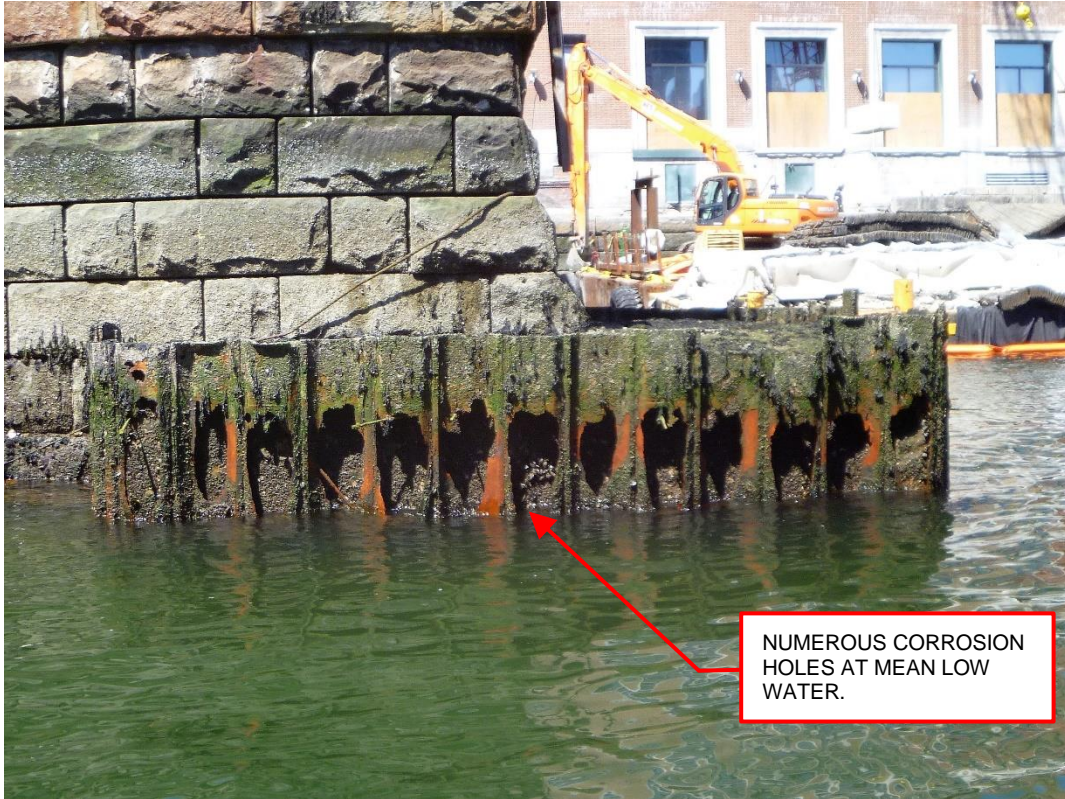
Photo 15 – Corrosion holes in steel sheet pile for concrete encasements.

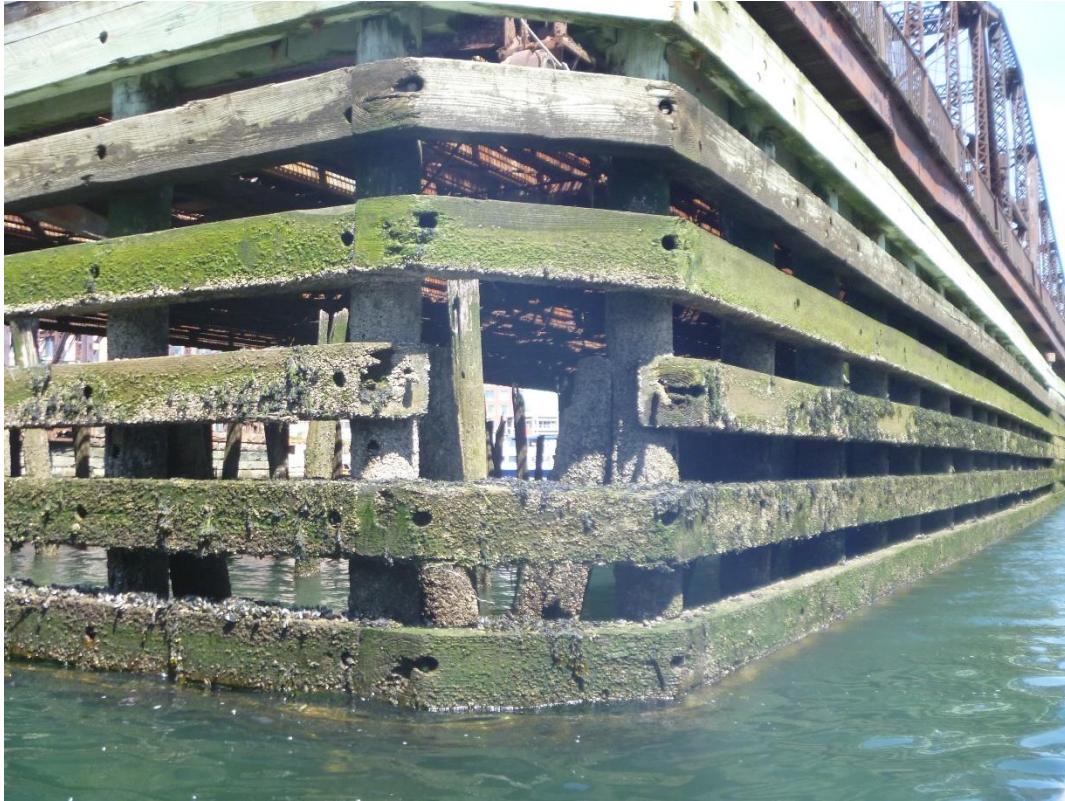
Photo 25 – Missing timber wale section at south corner of West Fender System.

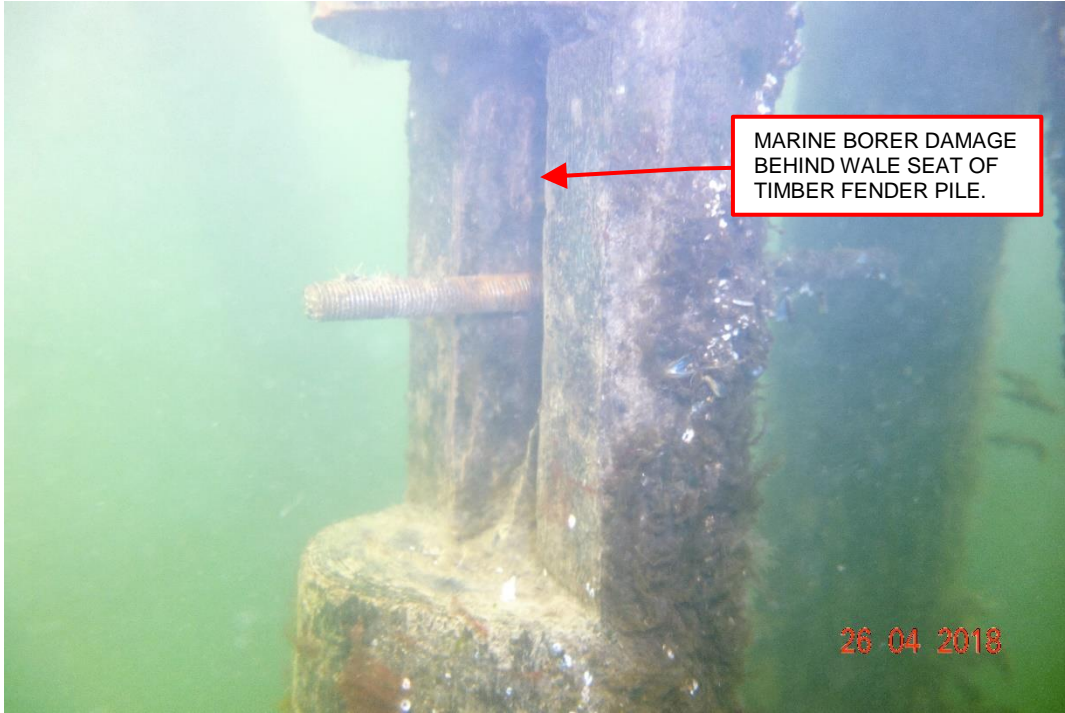
MARINE BORER DAMAGE
BEHIND WALE SEAT OF
TIMBER FENDER PILE.
