Report on the Potential Designation of

The Hutchinson Building
29 Bromfield Street, Boston, Massachusetts 02108

As a Landmark under Chapter 772 of the Acts of 1975, as amended

Draft report posted on December 29, 2023
Amended report posted on February 16, 2024

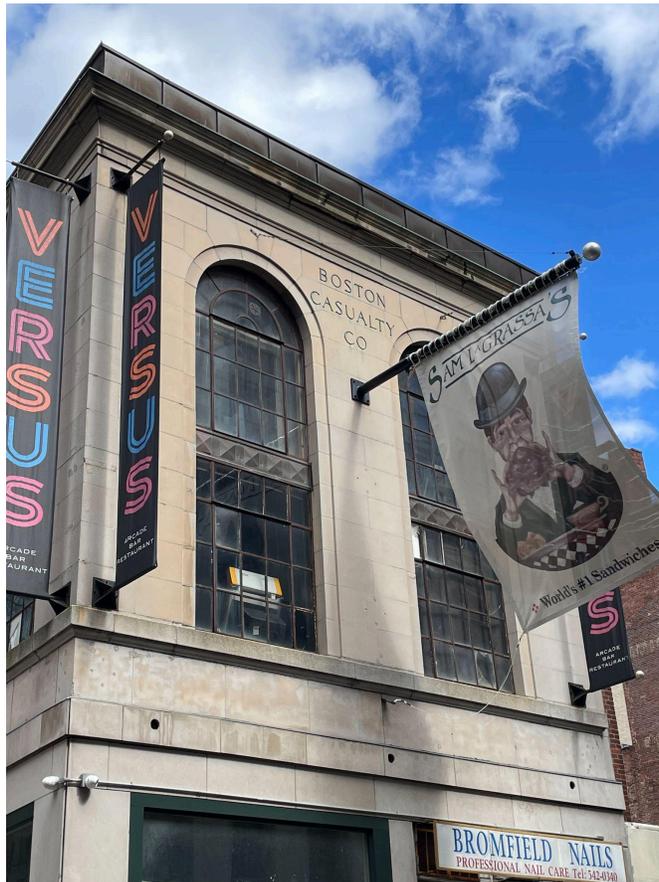
Figure 8. Detail of Bromfield St. elevation, upper levels. Photograph taken from Bromfield St., facing northeast (March 26, 2023). Photo credit: Mary E. Cirbus.

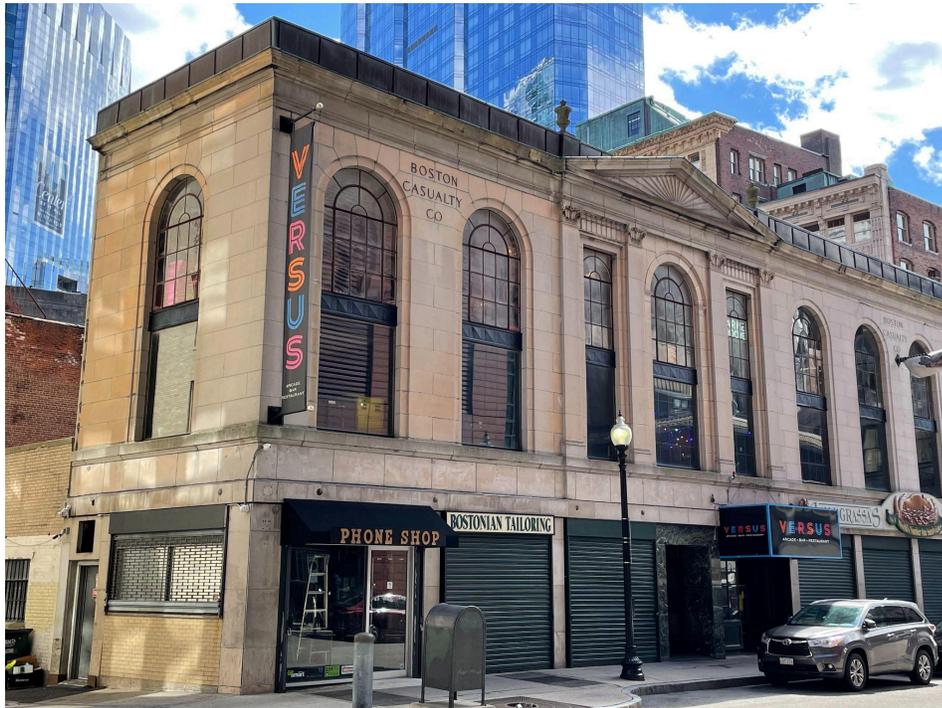
Figure 9. Detail showing the one bay of Province Court elevation, and (from left to right) bays 1 through 8 of Province St. façade. Photograph taken from Province St., facing southeast (March 2023). Photo credit: Mary E. Cirbus.

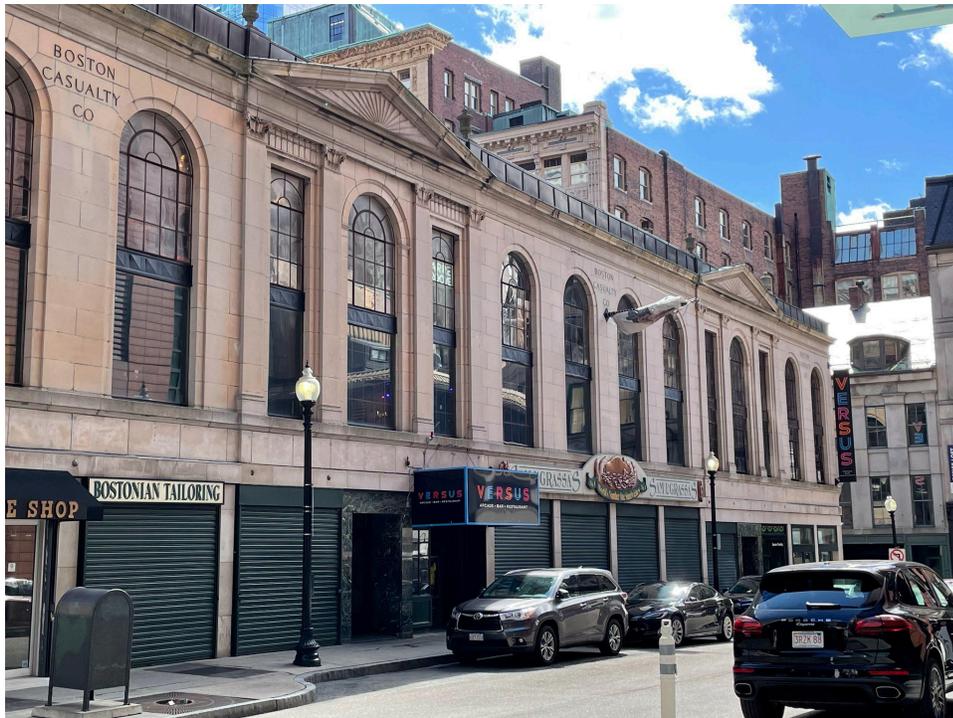
Figure 10. Detail showing (from left to right) bays 1 (partial) through 14 of Province St. façade. Photograph taken from Province St., facing southeast (March 26, 2023). Photo credit: Mary E. Cirbus.

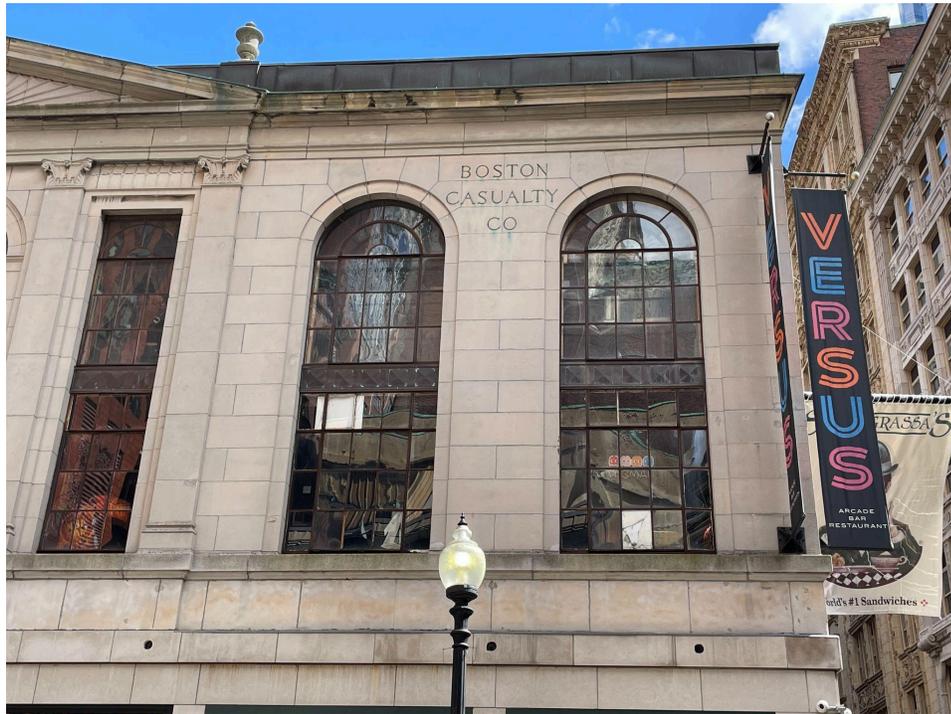
Figure 15. Detail showing (from left to right) the upper portions of bays 12 through 14 of Province St. façade. Photograph taken from Province St., facing east (March 26, 2023). Photo credit: Mary E. Cirbus.

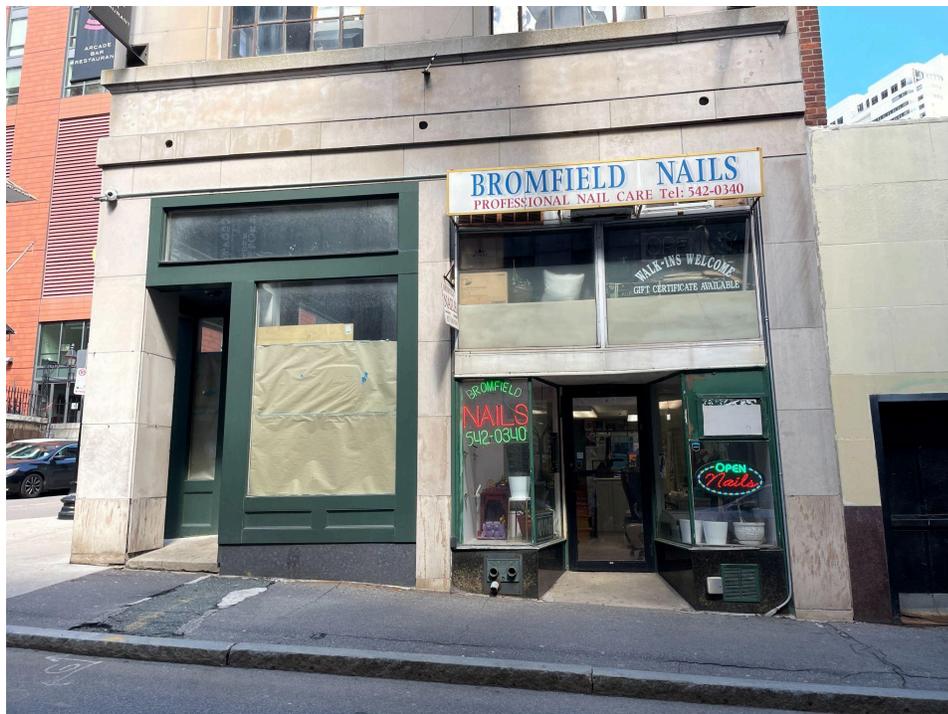
Figure 16: Detail image showing modified storefronts on Bromfield St. Photograph taken from Bromfield St., facing north (March 26, 2023). Photo credit: Mary E. Cirbus.

The bottom third of the façade consists of a row of storefronts along the street level, capped by a wide sign band and molded water table. A row of metal caps and holes in the cast stone where caps are missing is evenly spaced across the façade, remnants of a former canopy that was historically present (see **Figure 3**). Province St. is not level, and the building is built into the slope of the street. The south elevation (facing Bromfield St.), therefore, sits at a lower level than the Province St. and Province Ct. elevations. The southernmost storefronts of the elevation (toward Bromfield St.), have higher bulkheads and additional cast stone above the windows to accommodate the slope of the street. Cast stone piers separate each of the storefronts, except underneath bays 3 through 5, and 10 through 12. All the storefronts have been modified from their historic design and are constructed of wood and metal materials. Two storefronts maintain an identical mosaic pattern within the recessed entries, which indicates that this feature may be original. Marble cladding is present at the two main entrances to the building, which are located underneath bay 4 and bay 11 (these entrances correspond with the center bay of each temple-front). These entrances also share the same mosaic floor as the previously mentioned two storefronts.

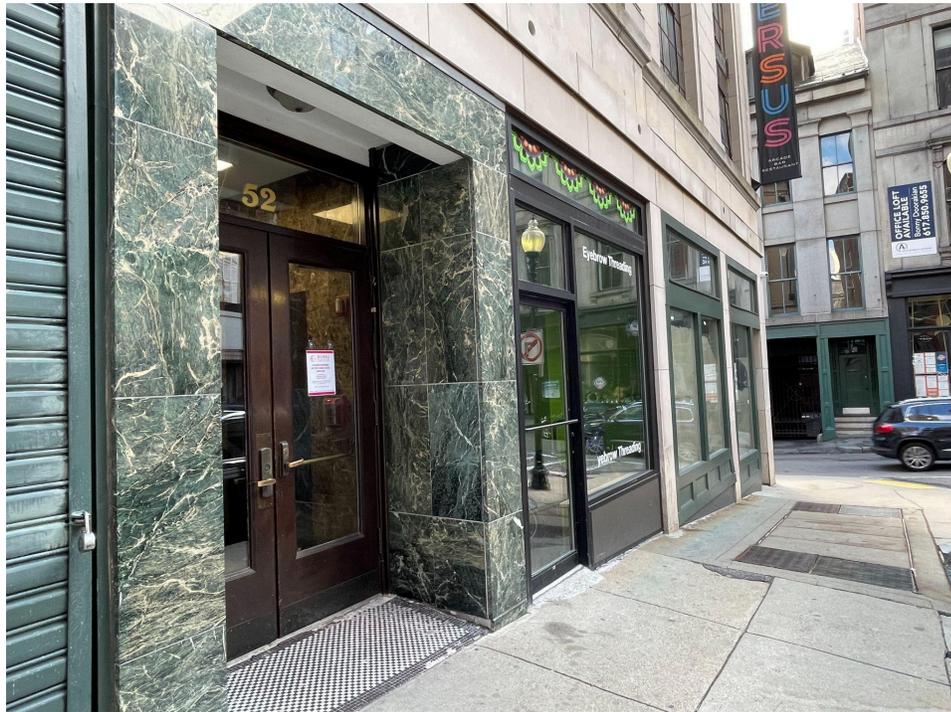
Figure 17. Detail image showing modified storefronts on Province St. compared to original facing of green marble (on left). Photograph taken from Province St., facing southeast, towards Bromfield St. (March 26, 2023). Photo credit: Mary E. Cirbus.

The original plans also show marble trim at each storefront pier, bulkheads, and at the surrounds of each main entrance. A 1934 photograph of the Hutchinson Building shows the original configurations of the recessed entry storefront plan, but it is not decipherable as to whether or not the marble trim was present (see **Figure 38**). The main entrances to the building on Province St. (bays 4 and 11) currently display green and white marble trim.

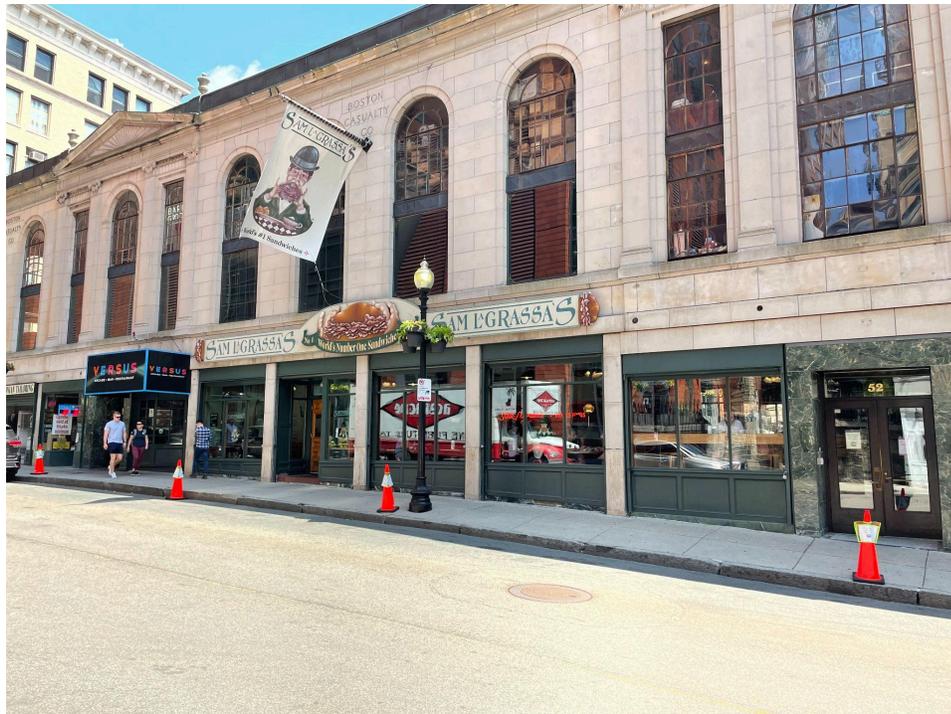
Figure 18. Expanded image showing extent of storefront modification on façade. Photograph taken from Province St., facing northeast (May 8, 2023). Photo credit: Mary E. Cirbus.

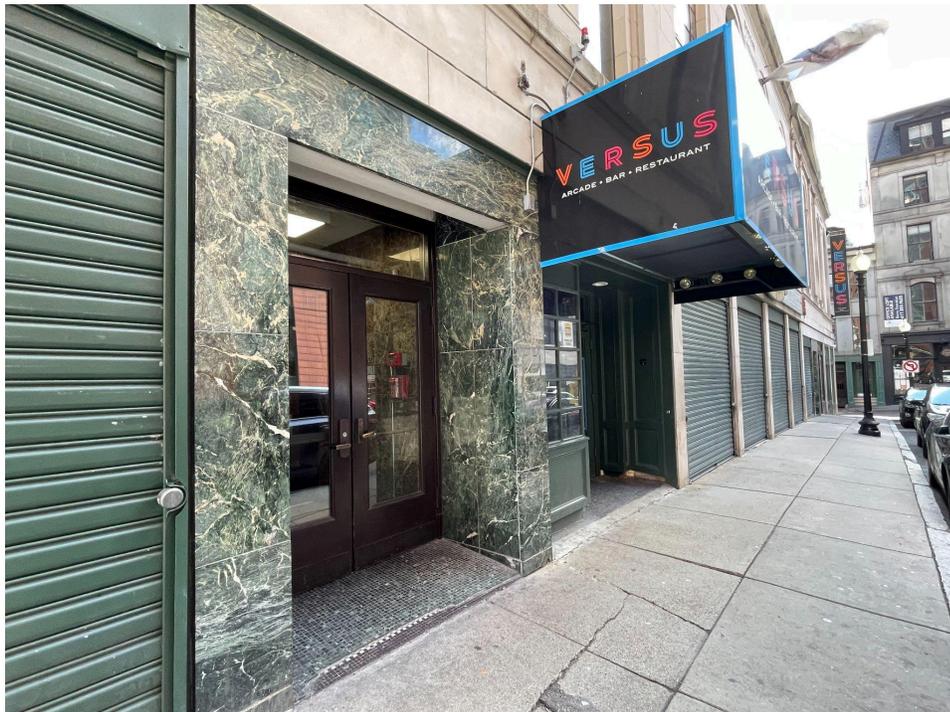
Figure 20. Detail image showing another original storefront with marble and recessed entry, as well as modified storefronts along the façade. Photograph taken from Province St., facing southeast, towards Bromfield St. (March 26, 2023). Photo credit: Mary E. Cirbus.

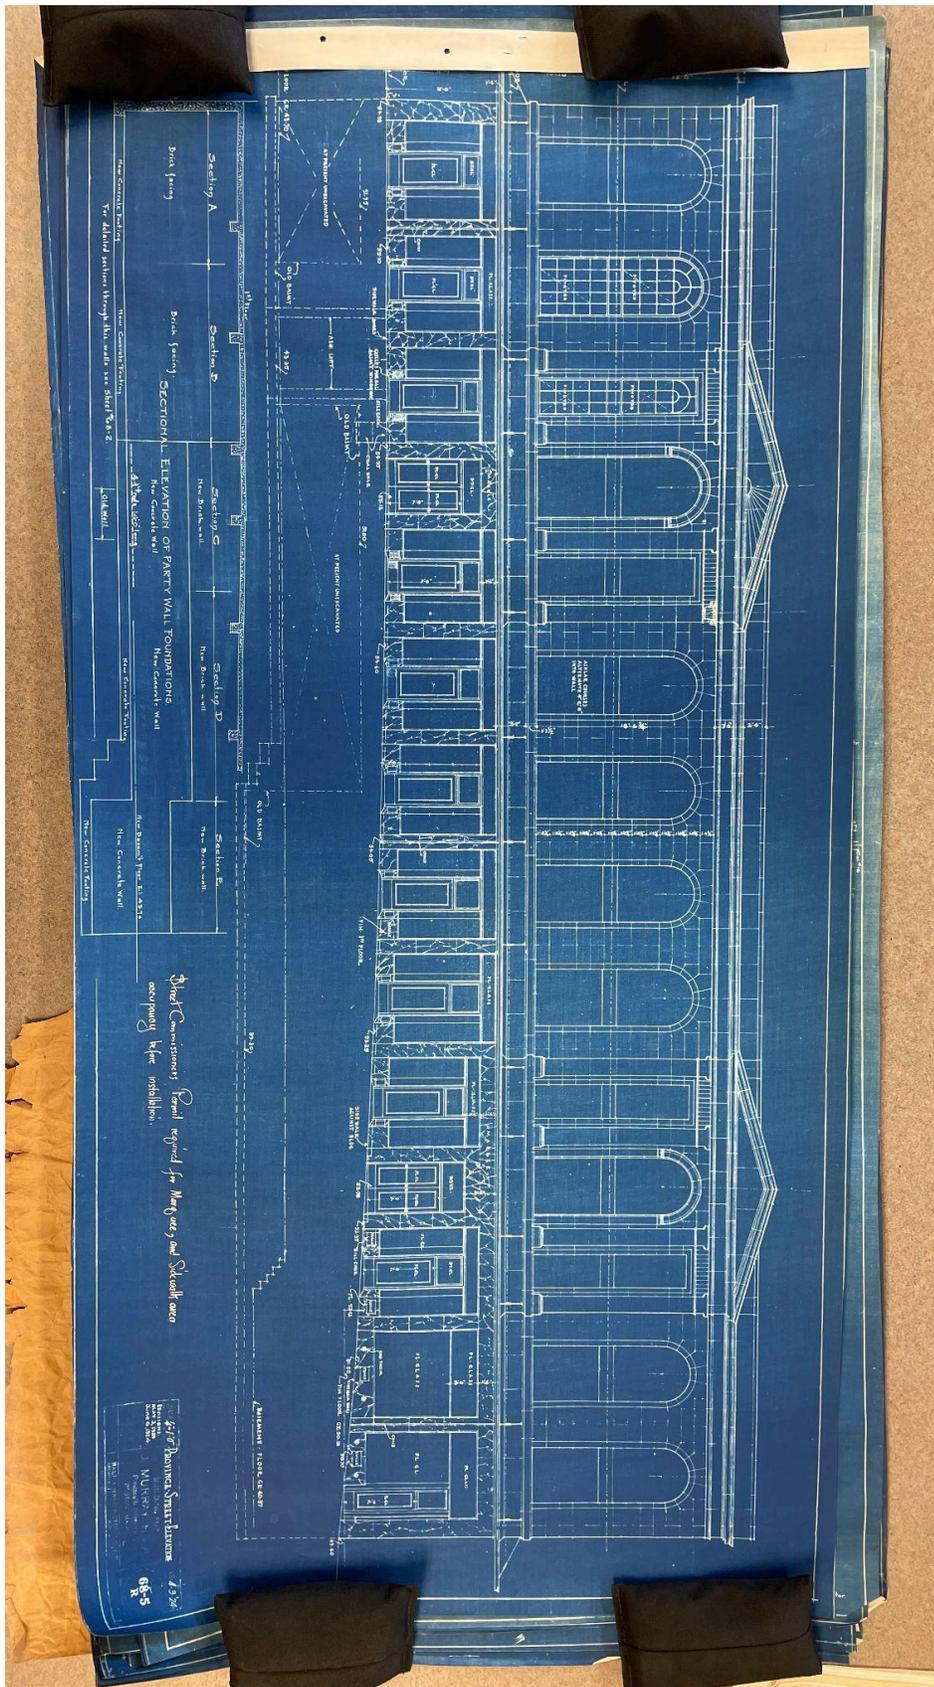
Figure 28. Original building plans showing the Province Street façade.
Source: Boston City Archives.

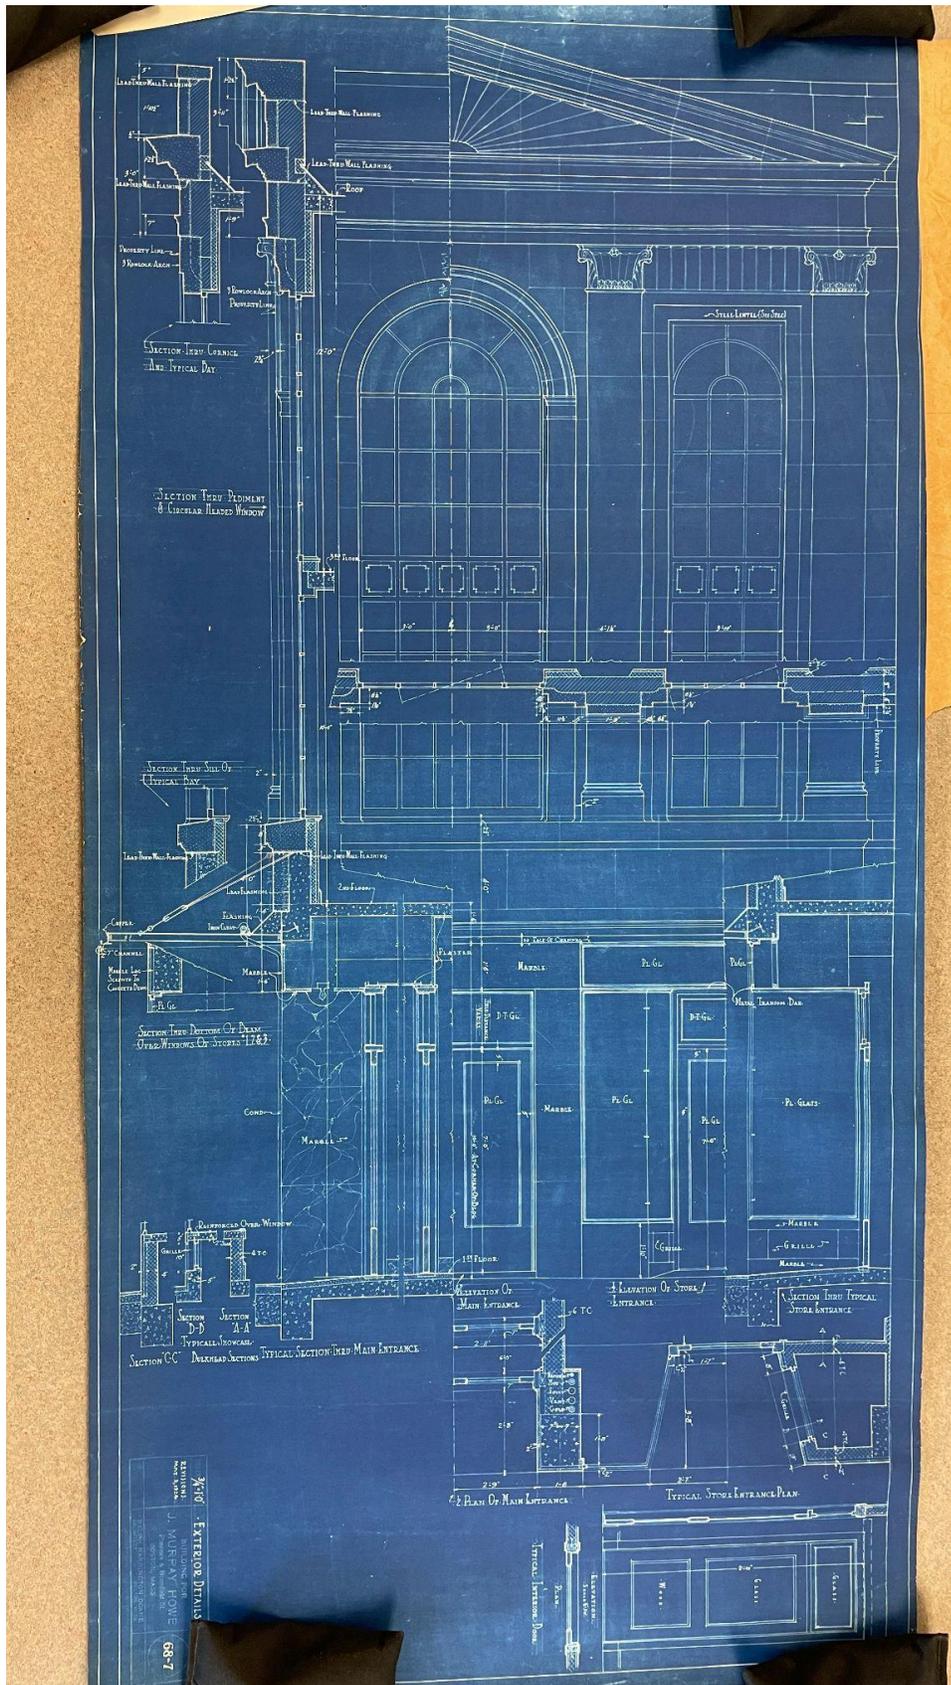
Figure 29. Original building plans showing exterior details.
 Source: Boston City Archives.

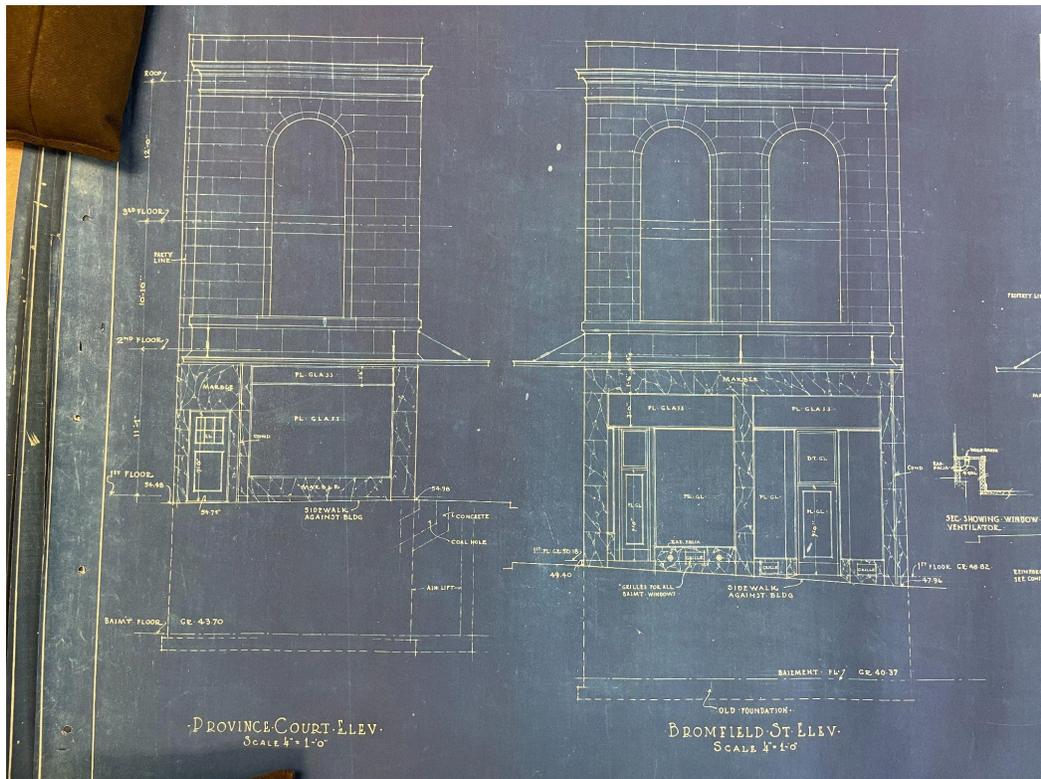
Figure 30. Original building plans showing the Bromfield St. elevation and Province Ct. elevation.

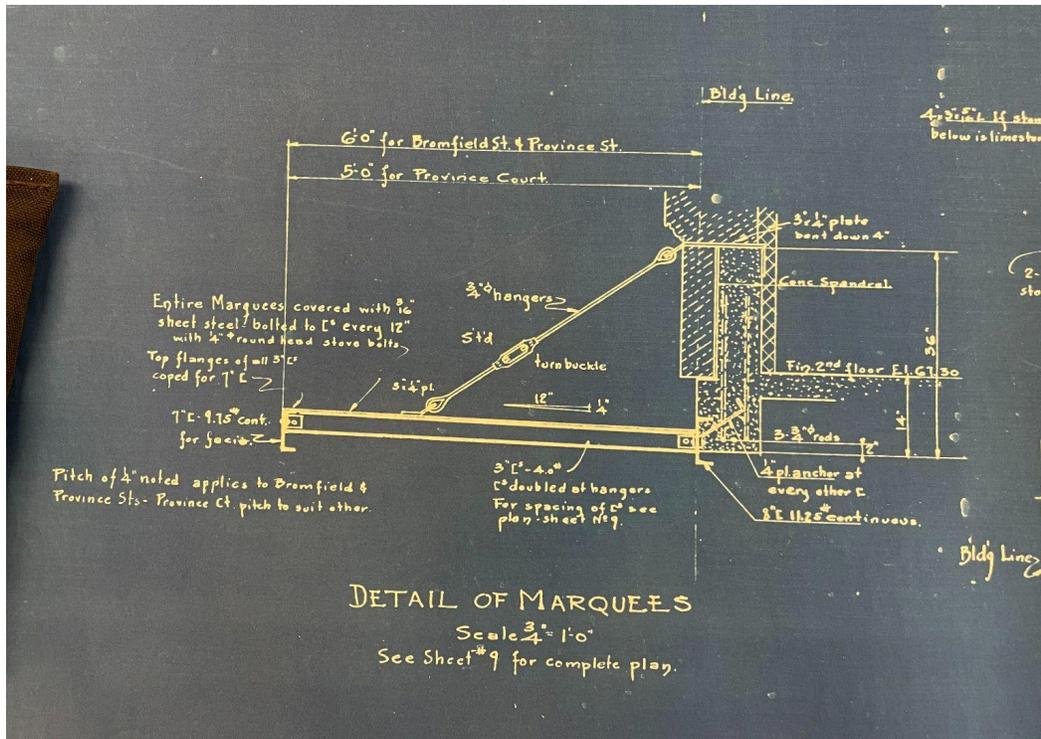
Figure 31. Original building plans showing a detail of the marquees on the street-facing façade and side elevations.

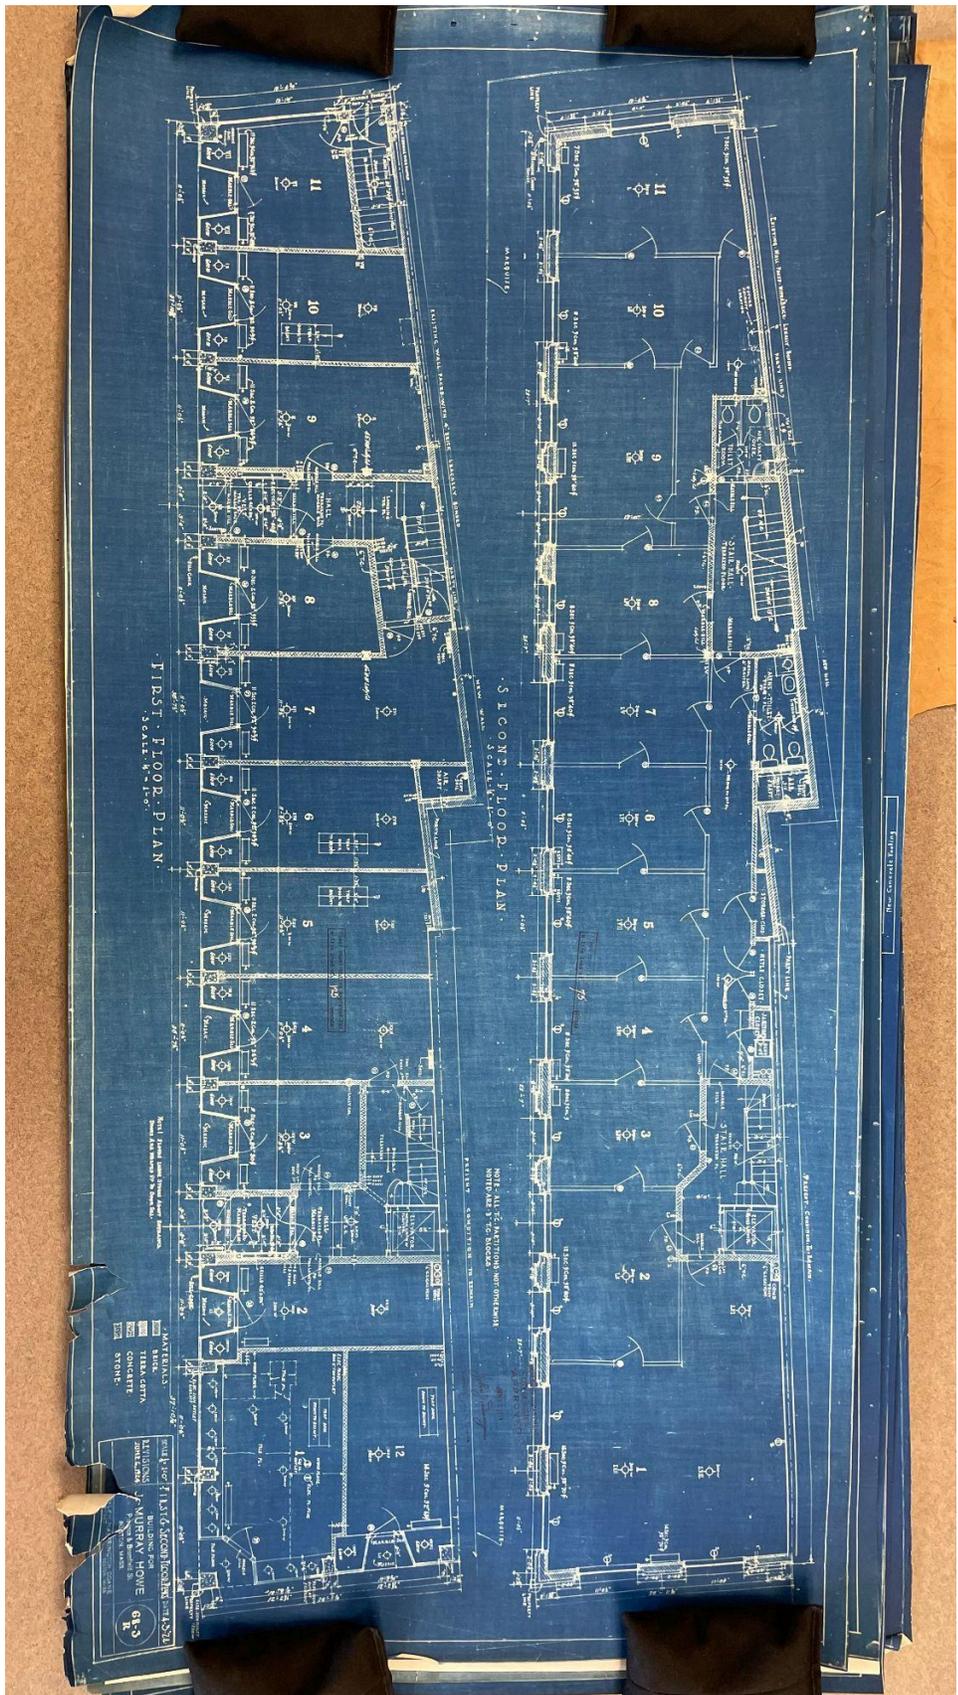
Figure 32. Original building plans showing the first and second floor plans.
 Source: Boston City Archives.

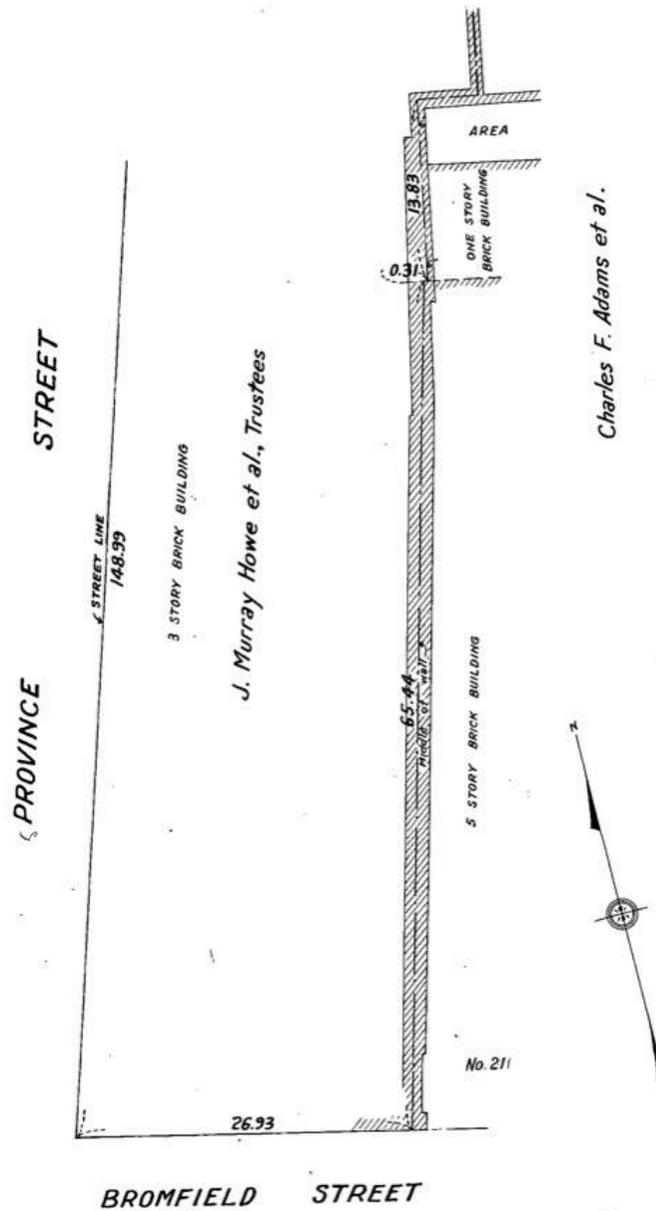
12 10
 4 1 15
 The original of this Plan was left
 for Record in the Suffolk Registry
 of Deeds, and is on file.
 A True Copy
 Reduced to scale 8 Ft to an inch
 In two sheets SHEET 1
 Louis A. Chase, C.E.

Plan of Land in Boston.
 Scale 4 feet to an inch.
 Dec. 19, 1924 Aspinwall & Lincoln, Civil Engineers
 46 Cornhill, Boston, Mass.

Figure 33. Plan of parcel containing Hutchinson Building.
Source: Aspinwall & Lincoln, Civil Engineers, December 19, 1924 (Sheet 1), as recorded in the Suffolk Registry of Deeds, Book 4676, Page 416. (Part 1 of 2)
 Suffolk County Registry of Deeds, <https://www.masslandrecords.com/suffolk/>

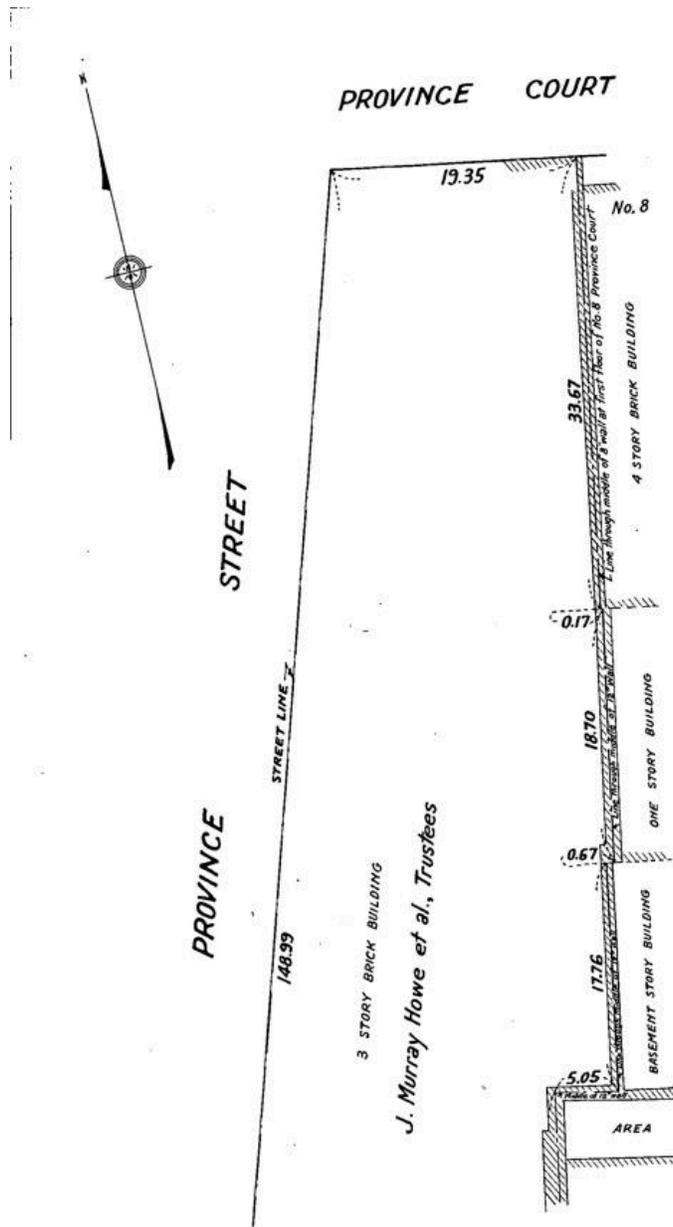
4616
 The original of this Plan was left
 for Record in the Suffolk Registry
 of Deeds, and is on file.
 A True Copy
 Reduced to scale 8 ft. to an inch
 In two sheets SHEET 2
 Louis O. Chase, C.E.

Figure 34. Plan of parcel containing Hutchinson Building by Aspinwall & Lincoln, Civil Engineers, December 19, 1924 (Sheet 2), as recorded in the Suffolk Registry of Deeds, Book 4676, Page 416. (Part 2 of 2)

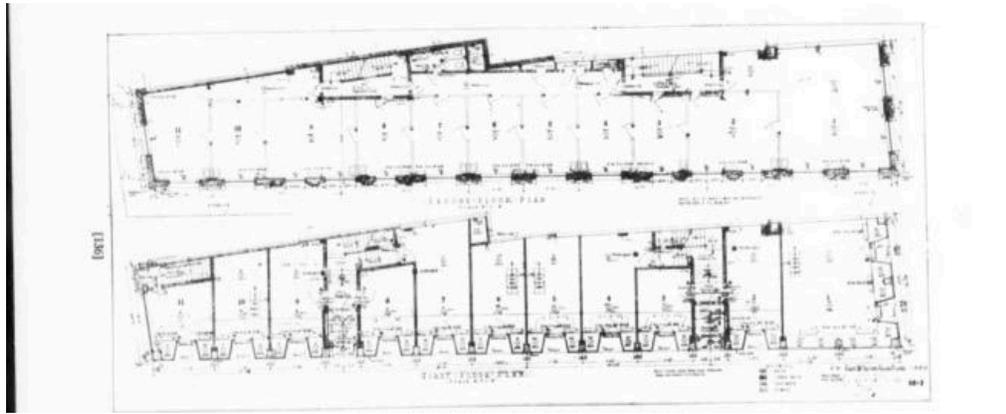
Figure 37. First and second floor plans of the Hutchinson Building, drawn by Ralph Harrington Doane, showing the original configuration of the street level footprint, including recessed storefront entries on Bromfield St. and Province St. The storefront at the corner of Province St. and Bromfield St. (bottom right corner), however, differs from the original building plans and shows an entrance on Bromfield St., rather than angled on the corner.

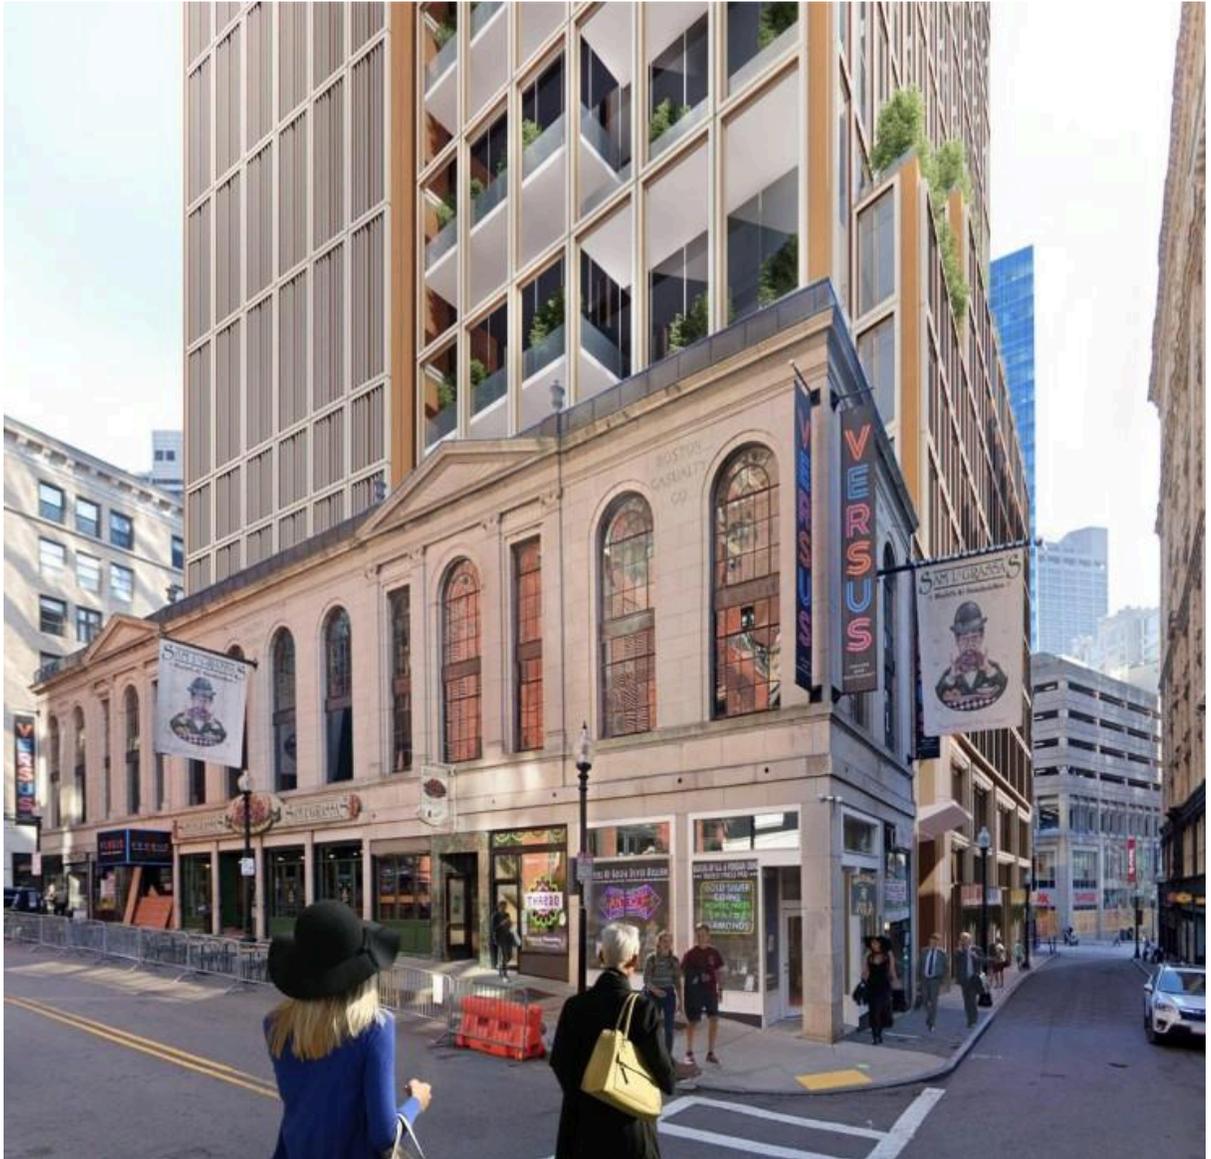
Figure 41: The Hutchinson Building in the foreground with the new 11-20 Bromfield rising behind. Image by Credit Arrow Street and the BPDA presentation, November 28, 2023.

At the time of the writing of this study report, the Boston Planning and Development Agency began a new planning initiative, PLAN: Downtown, to update the zoning code in the area of the Midtown Cultural District. At the same time that PLAN:Downtown was being developed, several impactful projects were developed by the BPDA through Article 80 Large Project Review and are in final stages of planning. One of these projects will have a direct effect on the Hutchinson Building. A new building planned for construction at 11-20 Bromfield St. involves the demolition of several nearby buildings: 11-21 Bromfield St, 349-363 Washington St., 365 Washington St., 367-369 Washington St. (also known as 1-9 Bromfield St.) A new 23-story building will directly abut the Hutchinson Building. As the new building is located to the southeast of the Hutchinson building, a large shadow will be cast not only on the historic

building but also on Province St. and Bromfield St. See **Figures 41-43** for the context of the new building in relation to the Hutchinson Building.

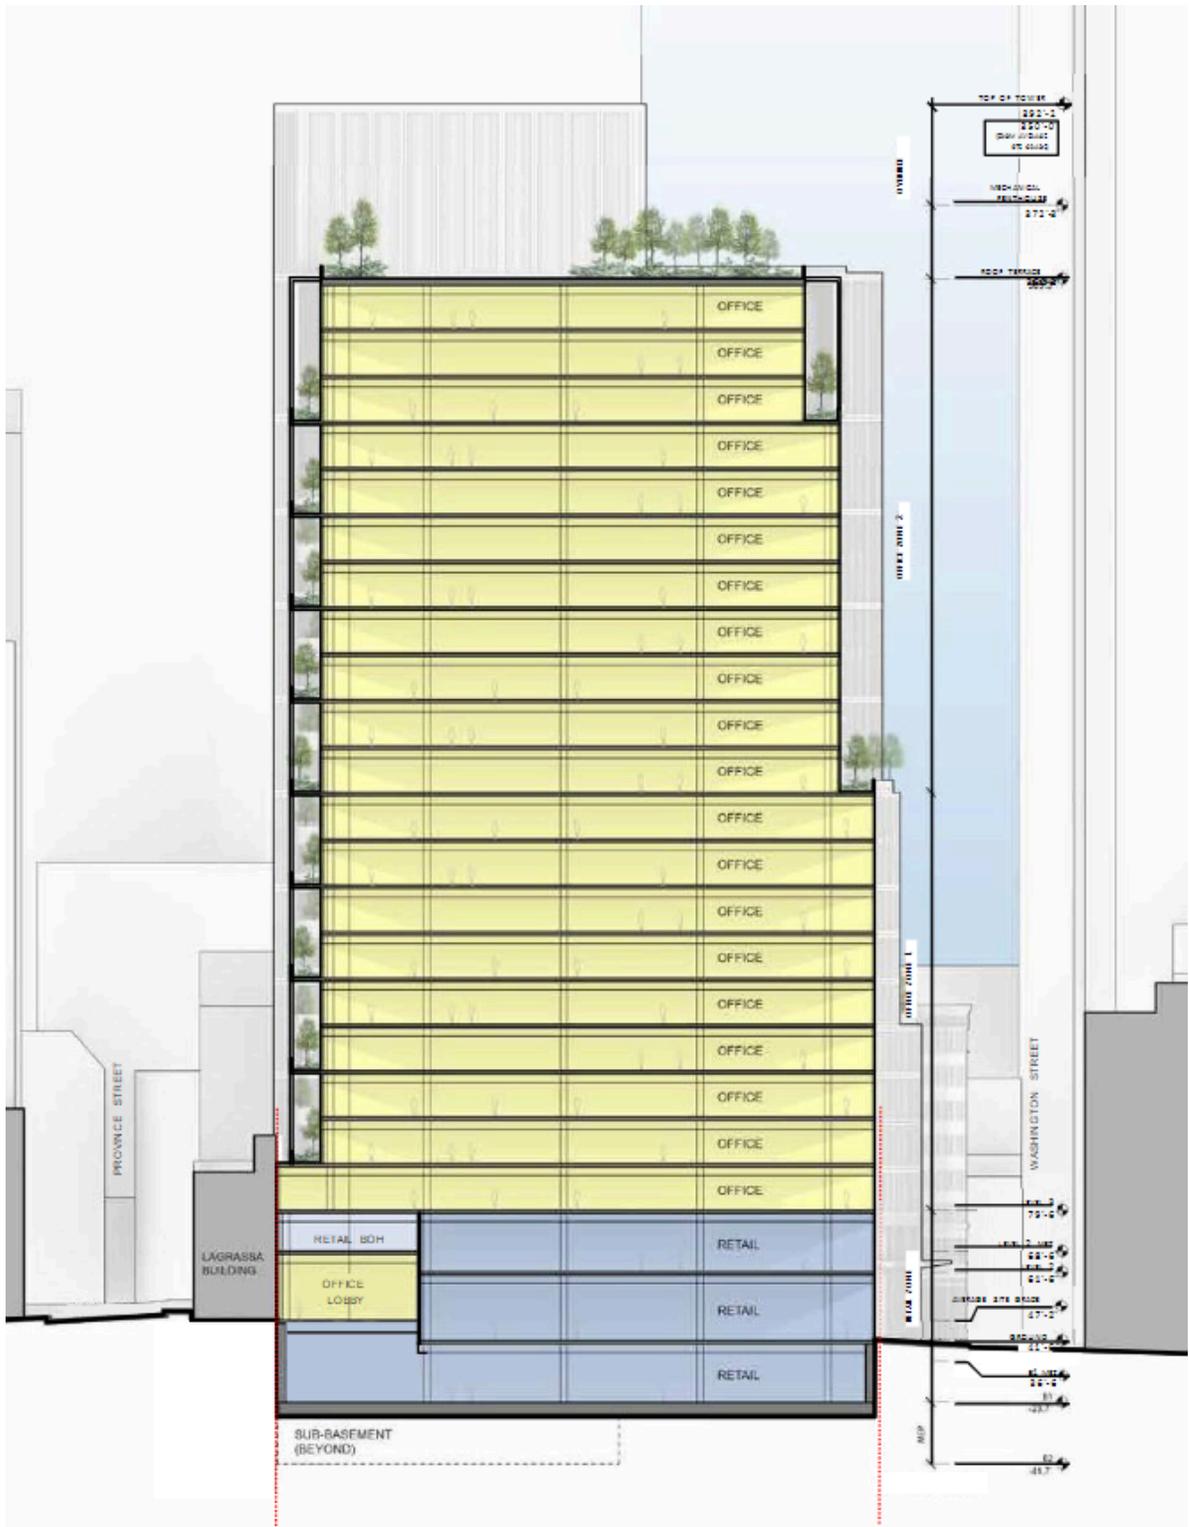
Figure 42: Hutchinson Building (LaGrassa) 3-Story Building to the left with abutting 23-Story Building. Credit: Arrow Street and the BPDA Presentation November 28, 2023.

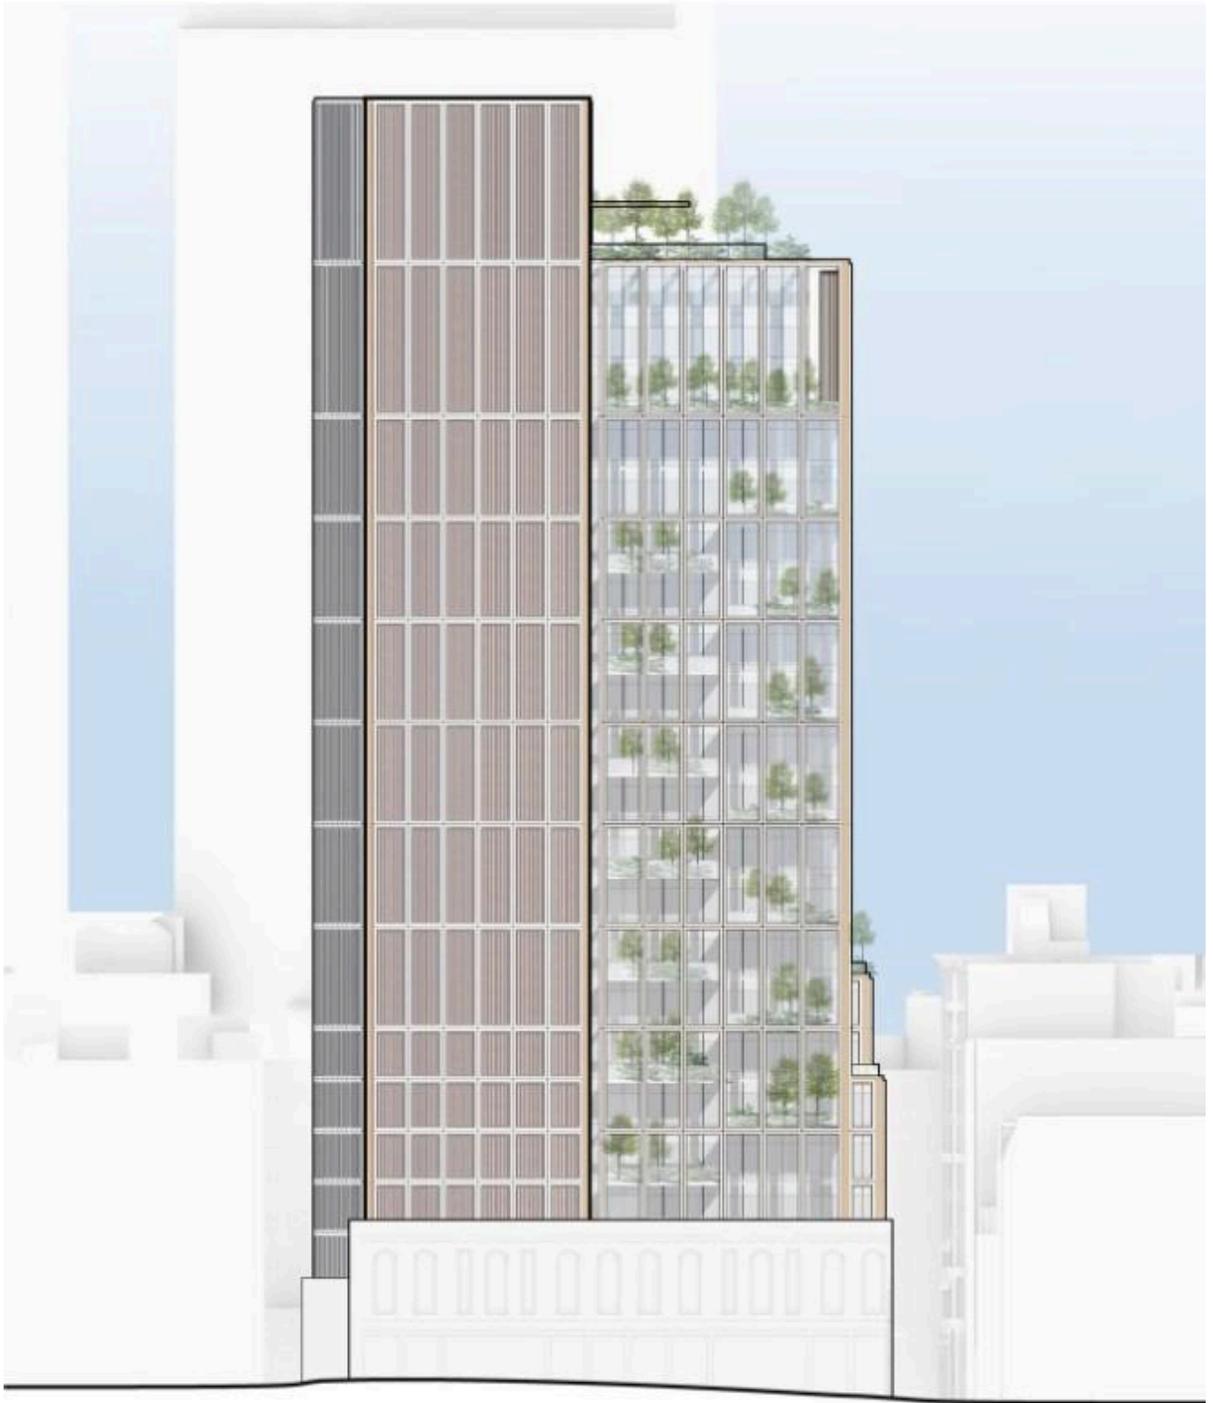
Figure 43: Hutchinson Building in the foreground of rendering of proposed development.
Credit: Arrow Street and the BPDA Presentation Drawings, November 28, 2023
