Boston City Hall

Conservation Management Plan

January 2021

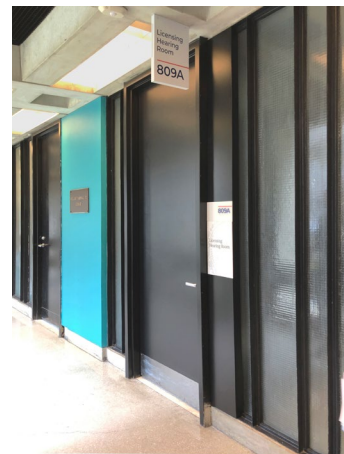
Entrance to the licensing hearing room showing newer hollow metal door and frame inserted into the mullioned interior storefront.

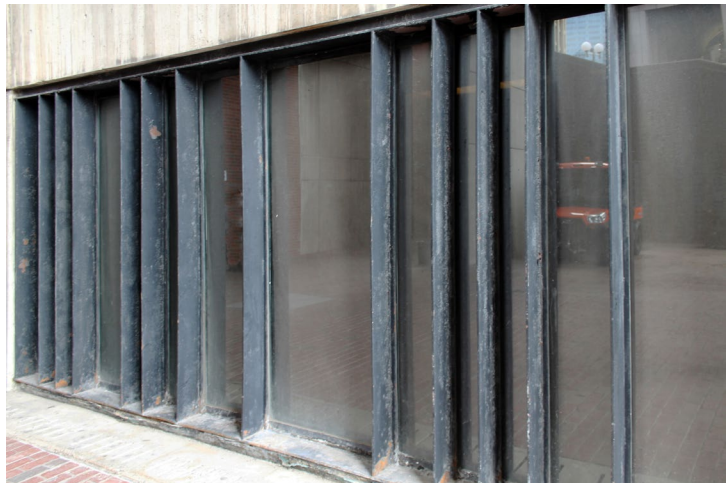
The steel mullions all show significant signs of coating failure on the exterior. As the coating has failed, rust has developed on these surfaces. There is no obvious evidence of structural failure in these mullions. Also the system is not energy efficient.

Right: Example of coating failure and subsequent rusting of mullions at exterior curtain wall. This location is at the Congress Street entrance, but the condition is typical.

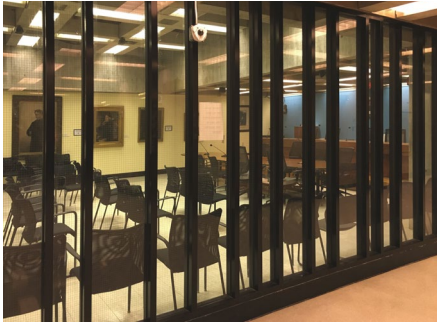
A standard storefront system that does not match the original has been installed in a few places, including at room 801.

Meeting room 801, showing the storefront system that does not match the original.

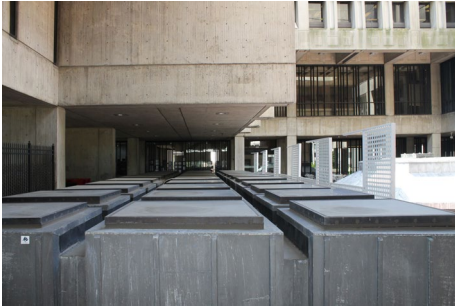
Bank of thirty-three skylights as seen in courtyard.

The acrylic covering for the bank of thirty-three skylights on the courtyard is dark, dirty, and provides little natural light to the transaction space below. Several of the coverings are cracked or broken. Due to various failures of the fixtures or bulbs, the supplementary lighting installed within the shafts is often not functional. Given that these skylights are partially located under the overhanging hood above, there is some question as to the effectiveness of this natural lighting strategy. Writing in the *Hudson Review* in 1970, art scholar Charles W. Millard observed that:

- | **M4** Restore the central skylight to provide daylight to spaces below.
- | **M5** Replace acrylic cover panels on the bank of thirty-three skylights to increase the amount of light that penetrates to the transaction area below.

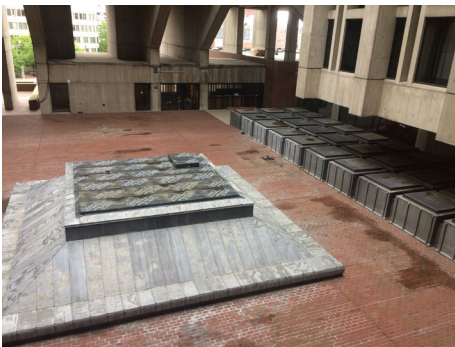
View of central skylight showing metal cladding and Grace I&W covering the top opening.

The oculus has suffered from extensive leaking, which results in mechanical failure of the escalators below. In response to these ongoing leaks, the top of the oculus has been sealed with W.R. Grace Ice & Water Shield.

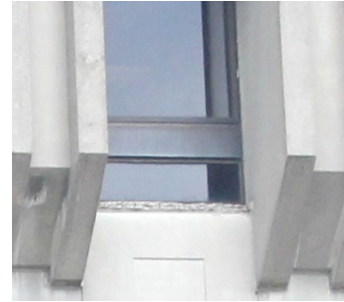
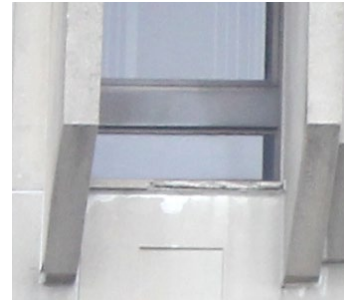
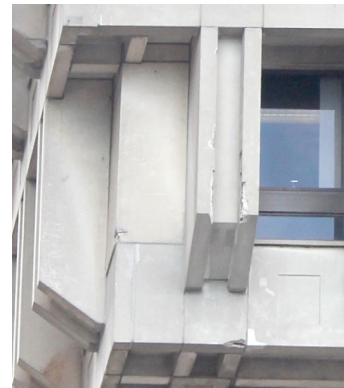
Conditions on the east elevation (along Congress Street) are significantly worse than conditions on other elevations. This is likely the result of prevailing harsh weather coming from the east.

East elevation at south corner (nominally above mayor's office suite); note multiple instances of spalled concrete on fins and window sills (June 21, 2018).

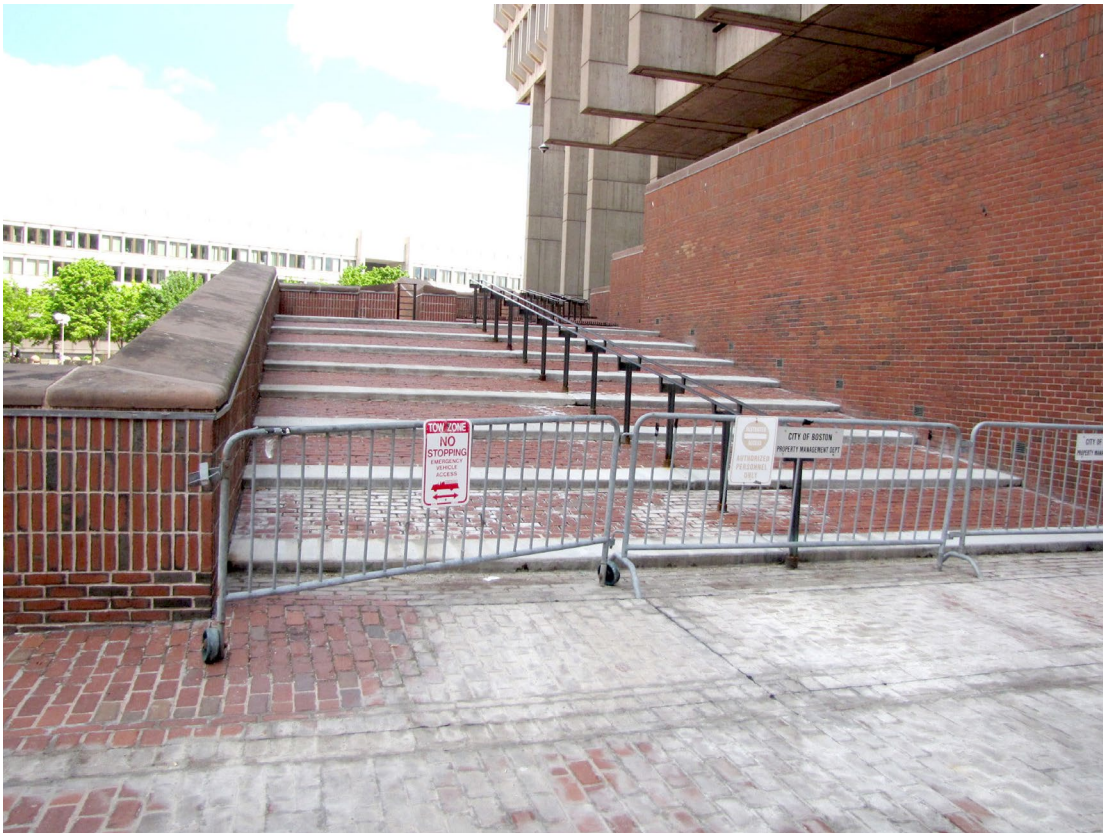
Top: General masonry failure adjacent to accessible ramp to the west entry (May 23, 2018).

Bottom: Staining from seasonal salt piles located in this area. Image also shows added concrete stair “nosings” which are not original (May 23, 2018).

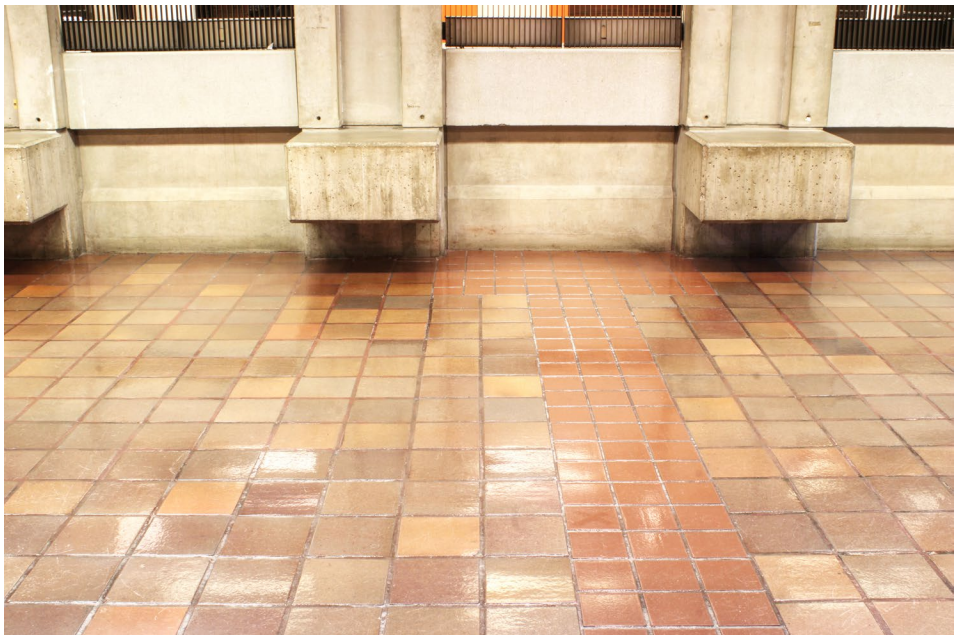
Clay tile showing a section replaced with an off-the-shelf material (January 11, 2021).

As quarry tiles are a glazed and fired compressed clay product, it may be more successful to source terracotta floor tile. This is an equivalent product in performance and can be colored and sized to meet matching requirements in support of the original design intent. It is highly unlikely

that appropriate tile will be readily available as a standard stocked product. It should be anticipated that a custom production run will be required. When factoring mockups for size and color range confirmation, lead times for product acquisition will have to be considered. Prior to acquisition, detailed planning of the replacement layout will be needed in order to implement control joints that were not a part of the original installation. The introduction of control joints will likely require slight adjustments in the size of replacement tiles in order to retain the visual alignment of the original installation.

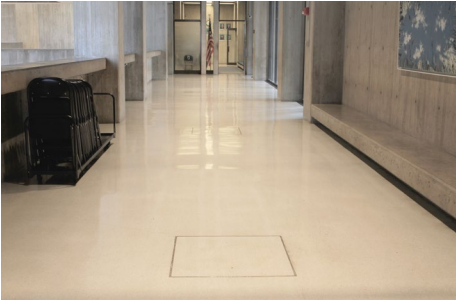
By July of 1968 there were several instances of delamination of the flooring on the fifth through ninth floors. These areas were described as “large blisters of approximately 2 to 3 feet in diameter.”³ Synterra Corporation of California (no longer in business) hypothesized three potential causes of the failure:

Polyester terrazzo floor on the fifth floor’s known delamination area (June 21, 2018).

- The use of localized space heaters after the floor work could cause thermal stress that could result in bond failure and warping in specific locations.
- Spillage of materials after priming and before application of the topping—this includes water. Apparently “a half ounce of water spilled just prior to pouring of the topping can cause a 3 foot diameter bond failure.”⁴
- The use of special additives such as calcium chloride, accelerators, retarders, or curing compounds.

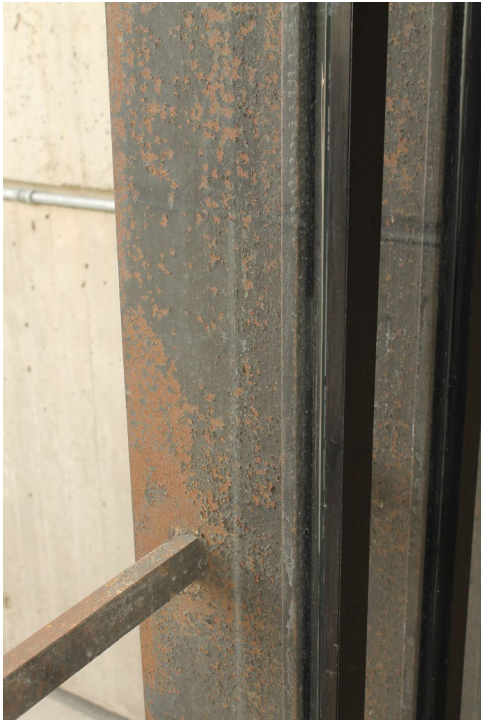
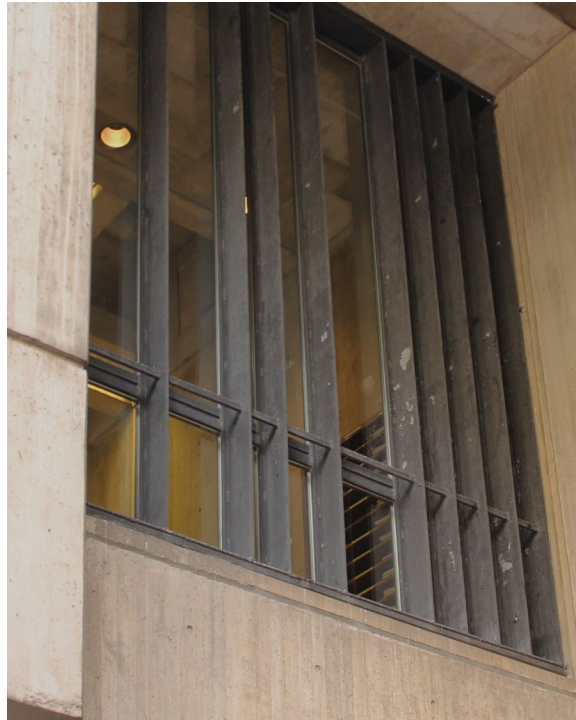
Typical window mullion conditions (March 29, 2018).

The steel window mullions located at levels five and lower are all showing significant paint loss with resulting rust development. Based on inspection of the mullions at various levels, it appears that the specified color (Dark Amber or Dark Bronze) was never implemented. All mullions (interior and exterior) are black. There is a small section of bronze colored mullions at the Congress Street entrance, but this appears to be a post construction replacement of a storefront unit at this sole location.

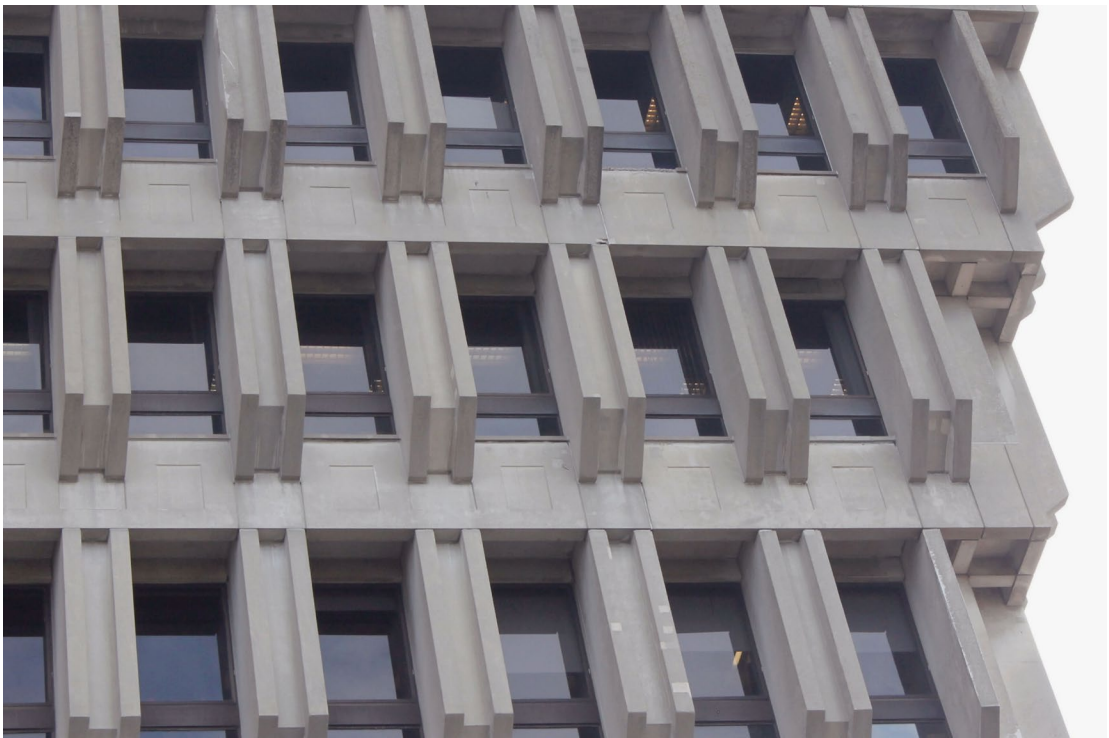
The glass is in good condition with some cracks observed. The most pressing concern for the glass is the low energy efficiency profile. The aluminum and steel windows lack thermal breaks, a condition that results in the transfer of heat or cold from the exterior directly into the interior. During extreme temperature swings, this often results in condensation build-up, which contributes to the deterioration of the window frames over time. Occupant comfort is also compromised, which ultimately results in increased energy consumption.

Typical window configuration at the municipal levels (June 21, 2018).

M48 Investigate window replacement options for the municipal levels. New windows should have the same tinting and general visual appearance but be more energy efficient with thermally broken frames and more easily and safely operated for cleaning. Features to be replicated include: fenestration pattern; jamb and sash thickness; glass color, texture and reflectance; and metal color. All windows on each elevation should be replaced at the same time if full replacement is considered.

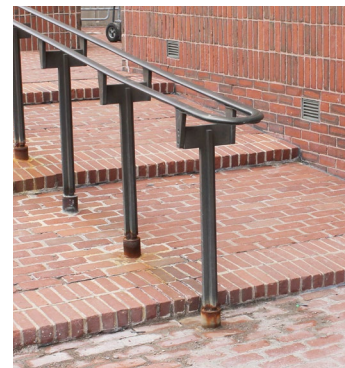
Rusting of railing attachment into the brick paving surface (May 23, 2018).

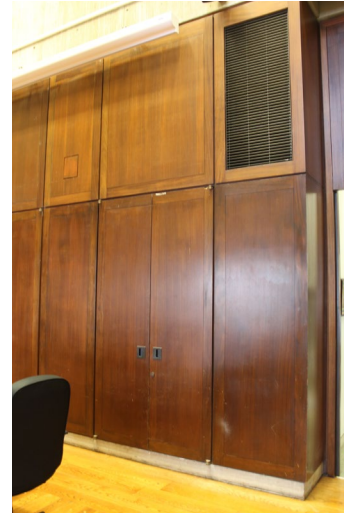
Wood-paneled wall, Eagle Room (June 21, 2018).

The wood features, primarily as observed on the fifth-floor ceremonial level, are in good condition. There is some evidence of scratches and nicks, but this is typical of normal wear and tear in a busy office environment.

M20 Wood doors and wood panels should be periodically reviewed for surface damage. Damage should be repaired with the gentlest means possible and color matched to the surrounding area.

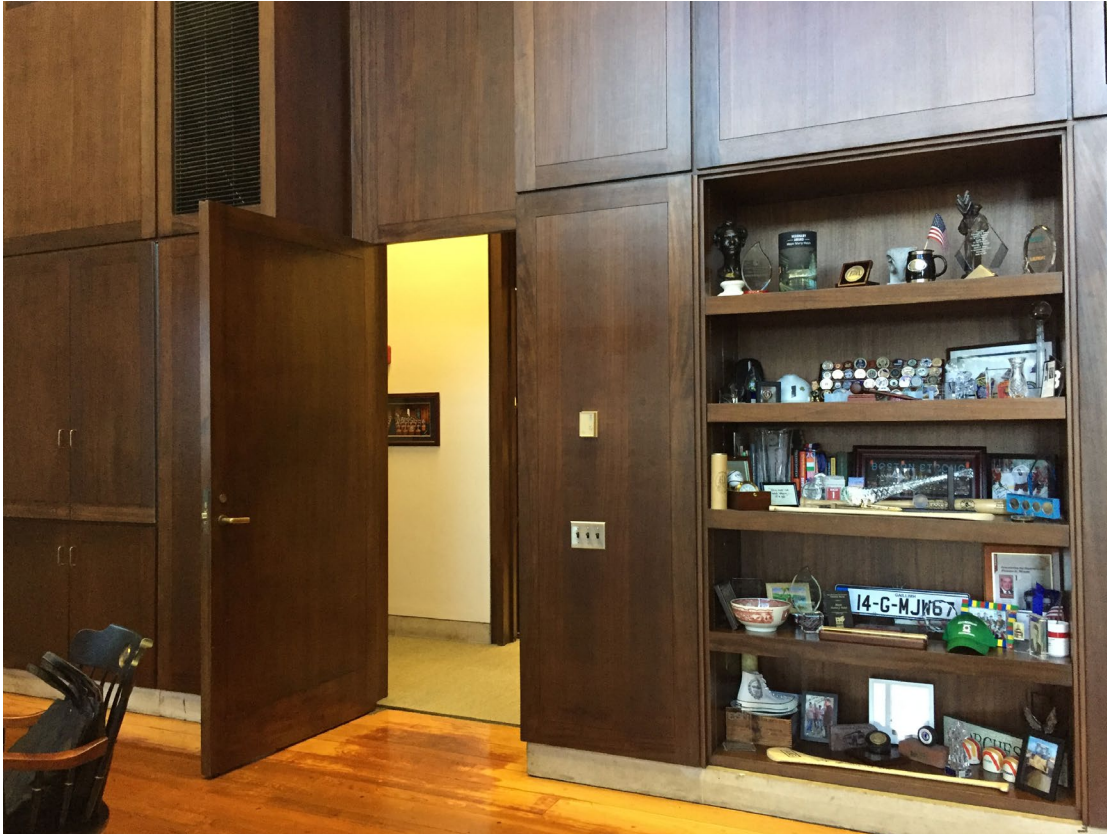
Wood-paneled wall, mayor's office.

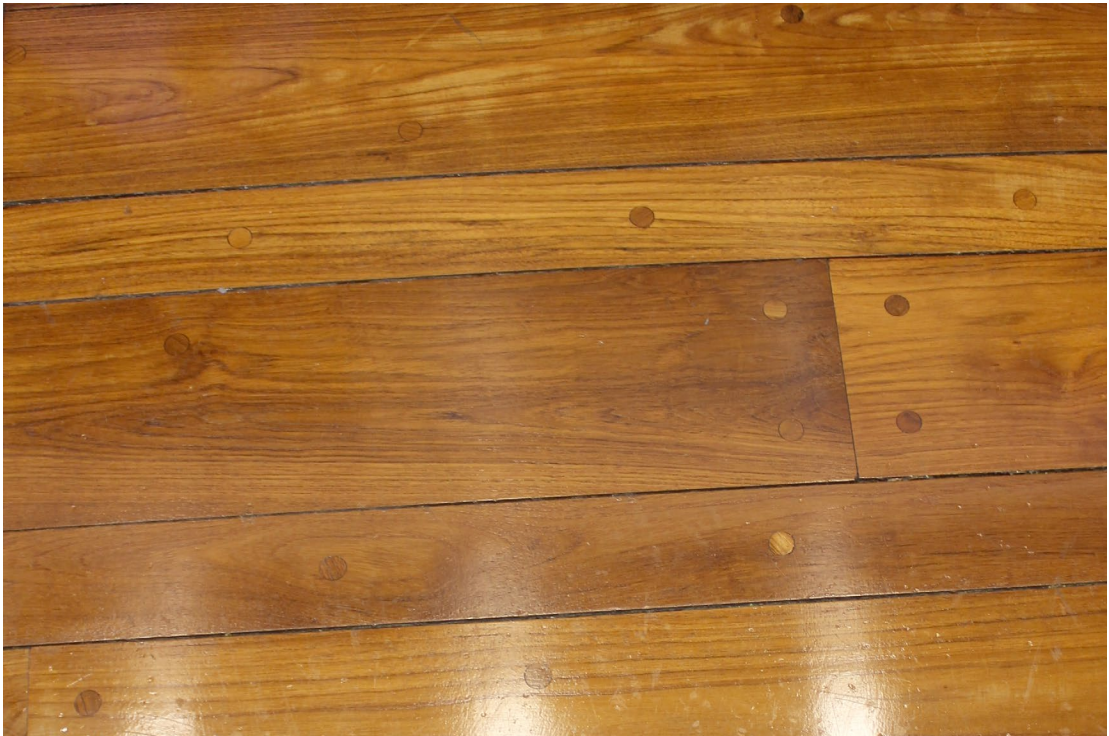
Wood floor, mayor's office showing plugged fastening holes (June 21, 2018).

M19 Wood floors in mayoral suite should be maintained as part of cyclical maintenance. Refer to “Recommended Procedure for Wood Flooring” in this document.

- Screening the floors every one to two years should allow for less invasive work, less down time, and less expense as compared to full refinishing.
- Where plugs for fastener holes in the floor have been removed, install new plugs matching as best as possible the wood species and the grain of surrounding floor boards. Plugs may be secured with PVA glue; epoxy is not necessary. The area of each plug should be treated (stain, protective coating) to match the surrounding flooring.
