RE: Northern Avenue Bridge Replacement Project

Project Name: Northern Avenue Bridge Replacement Project		
Street Address: Northern Avenue Bridge		
Municipality: Boston	Watershed: Boston Harbor	
Universal Transverse Mercator Coordinates: 331212.55 E 4691169.61 N, Zone 19T	Latitude: 42.354484° N	Longitude: -71.049435° W
Estimated commencement date: 01/2020	Estimated completion date: 2022	
Project Type: Bridge Replacement	Status of project design: 25 %complete	
Proponent: City of Boston Public Works Department		
Street Address: Boston City Hall, One City Hall Square, Room 710		
Municipality: Boston	State: MA	Zip Code: 02110
Name of Contact Person: Para Jayasinghe		
Firm/Agency: Boston Public Works Department	Street Address: 1 City Hall Square, Room 710	
Municipality: Boston	State: MA	Zip Code: 02110
Phone: (617) 635-4968	Fax:	E-mail: para.jayasinghe@boston.gov

Attachment 1 – Figures (USGS Map, Aerial Photo, FEMA Map)
Attachment 2 – Plans (25% Design)
Attachment 3 – ENF Distribution List
Attachment 4 – Permit List
Attachment 5 – Previous Correspondence with MHC
Attachment 6 – Substructure Inspection Report
Attachment 7 – Existing Condition Report

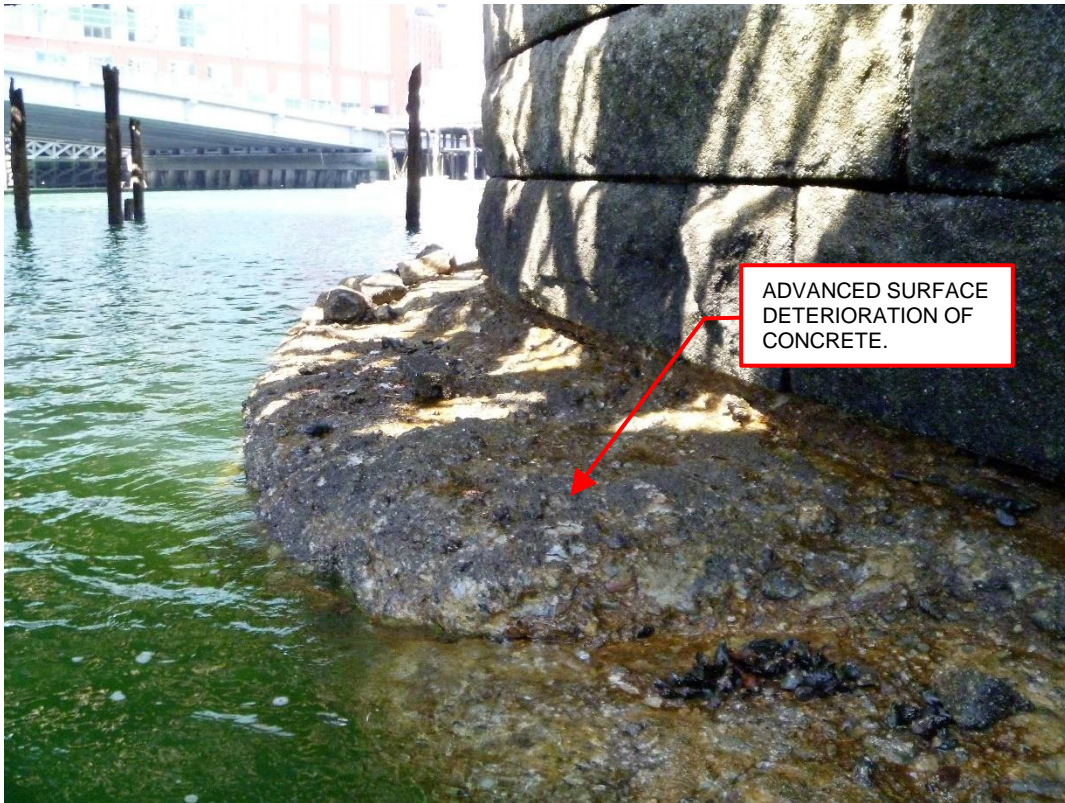
Overall the concrete footing is in **serious** condition and has general advanced surface deterioration with large areas of section loss, exposed aggregate and an irregular surface (See Photos 16 to 18). The concrete typically is 1/4" soft; no reinforcing steel was observed. The footing top corner is rounded due to a loss of concrete of up to 1 foot depth at the corner. The footing vertical face at roughly mid height has a 1 to 3 feet high layer of very soft concrete around the entire circumference of the pier (see Photos 19 and 20). The soft concrete was easily chipped away by divers using rock hammers. There are sporadic voids in the soft concrete layer up to 3 feet deep. Over approximately 50 linear feet on the footing north side, there is a 3 feet deep by 2 feet high continuous void in the soft concrete layer on the footing vertical face.

Photo 16 – Top of concrete footing near southwest quadrant of the Draw Pier.

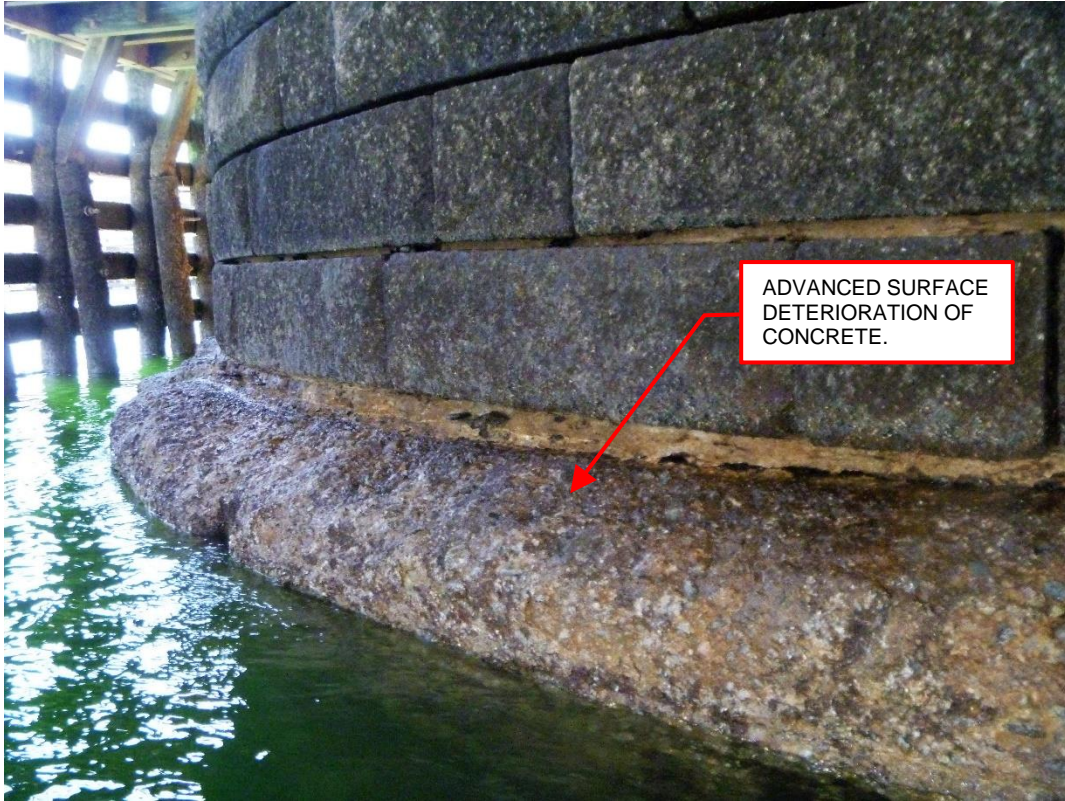
Photo 17 – Top of concrete footing near northeast quadrant of the Draw Pier.

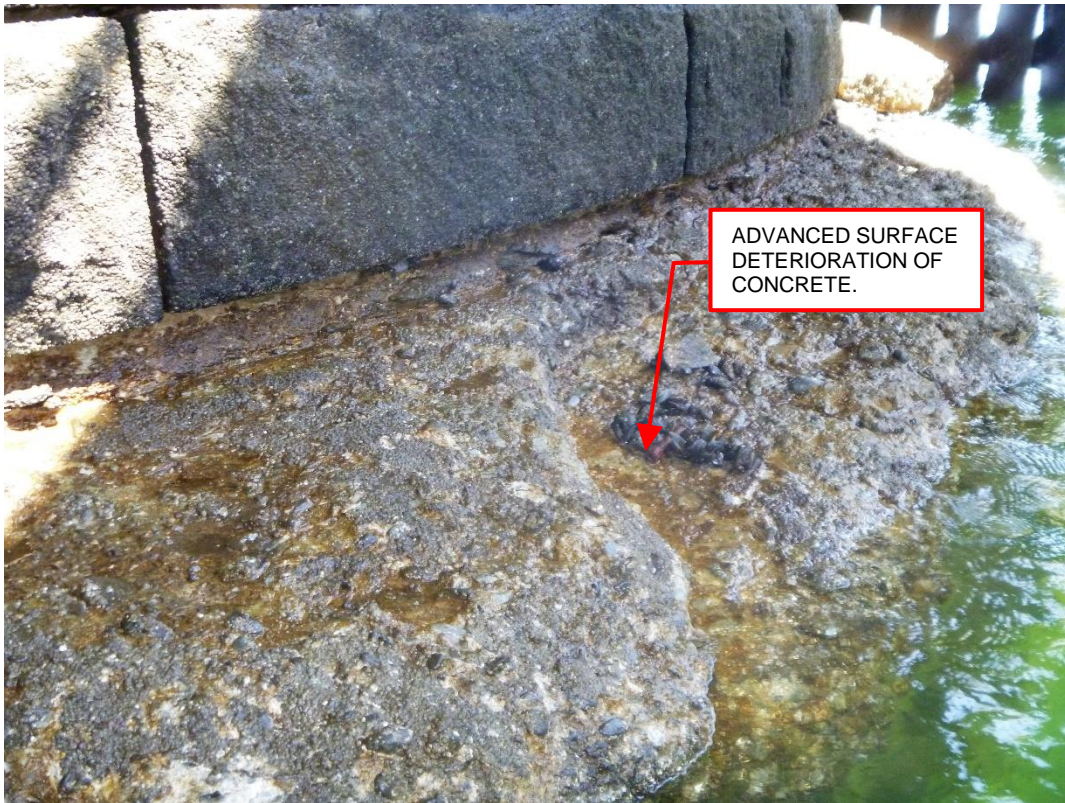
Photo 18 – Typical top of concrete footing for Draw Pier.

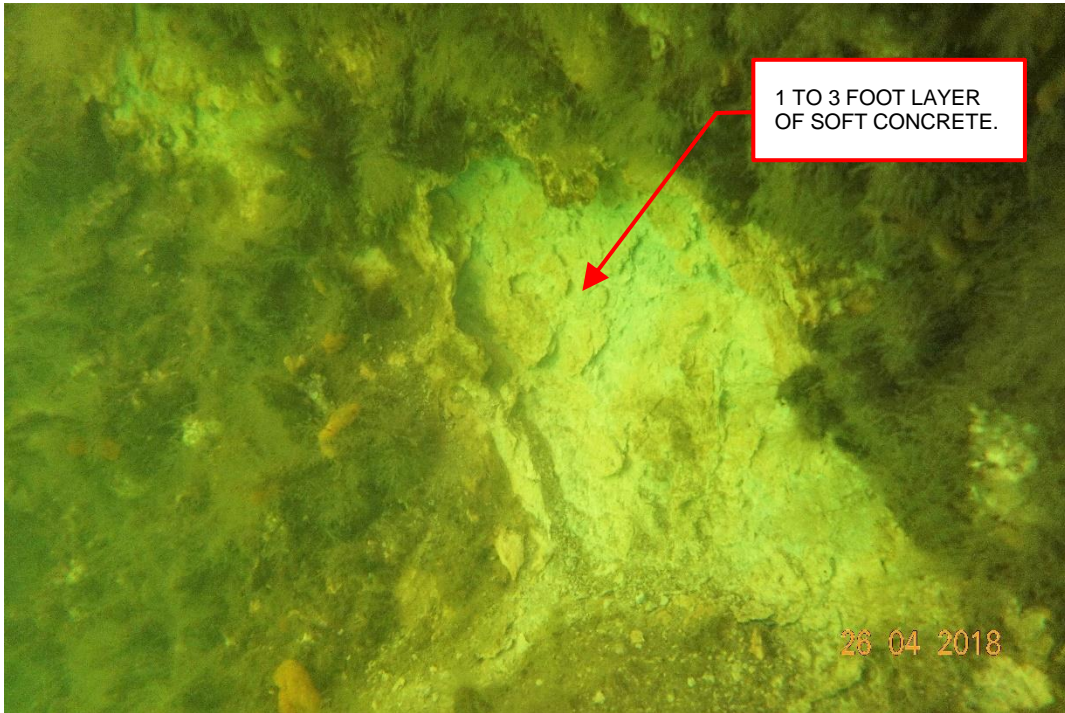
Photo 19 – Concrete footing for Draw Pier below water.

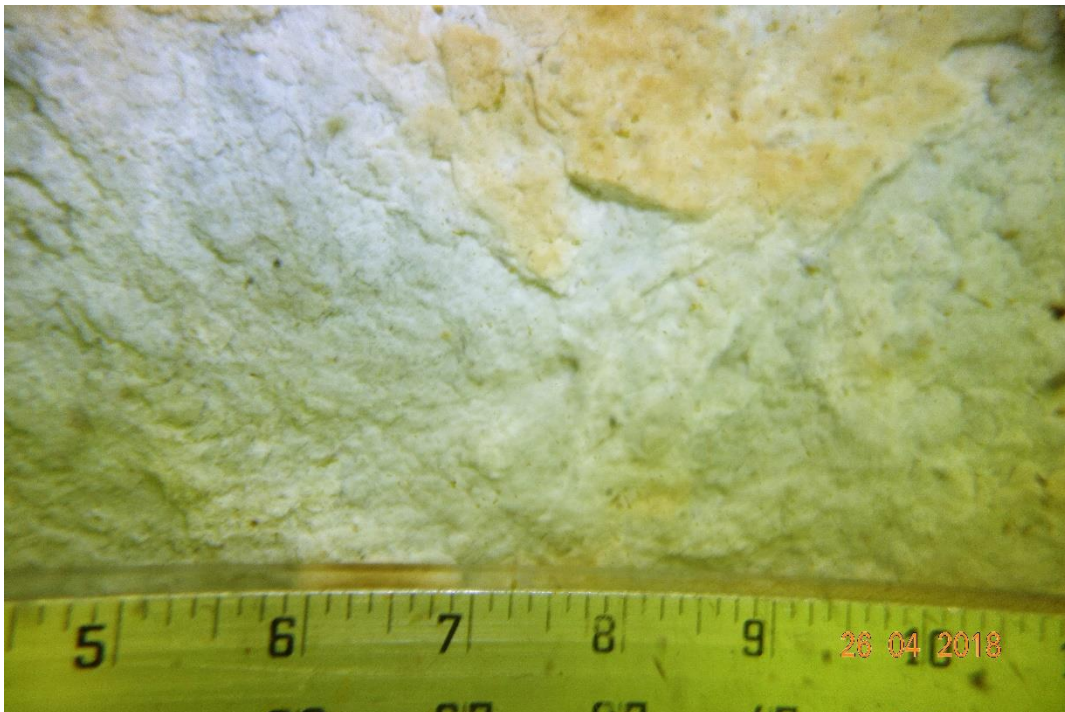
Photo 20 – Layer of soft concrete for the footing of Draw Pier below water.

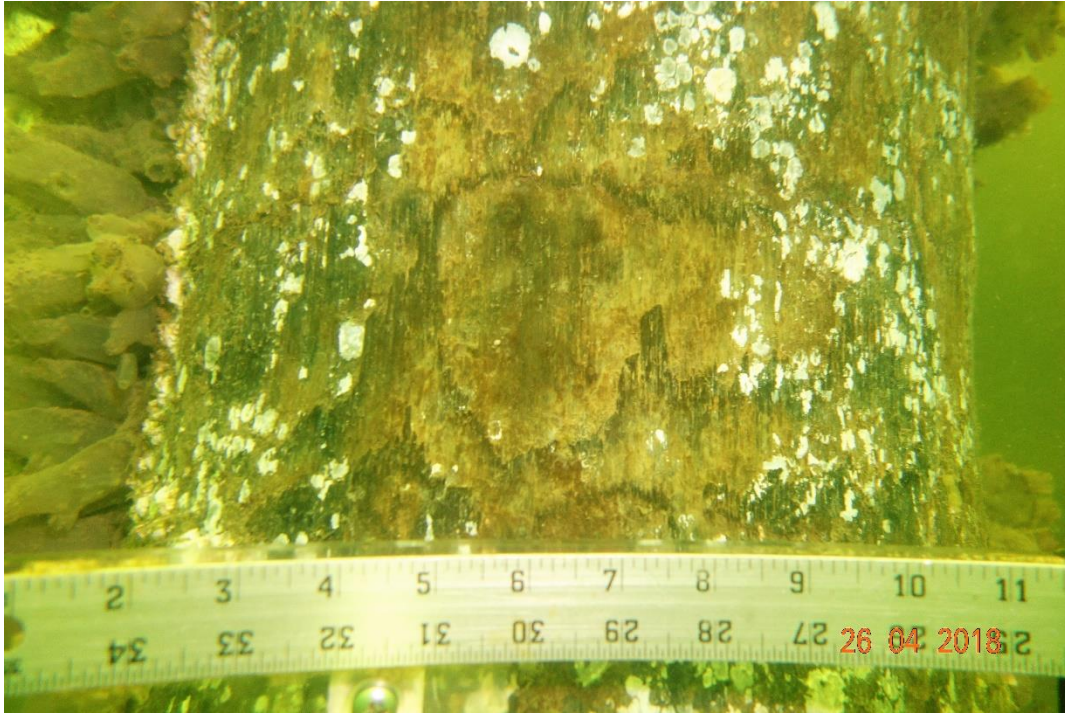
The Fender System has marine borer damage to the timber wales, isolated missing lower timber wale sections, missing connection bolts for the timber wales, and corrosion of connection hardware. No sealant material was noted on any of the countersunk bolt holes in the wales. No significant defects were noted on the timber piles (See Photo 21).

Photo 21 – Typical timber vertical pile for fender system below water.

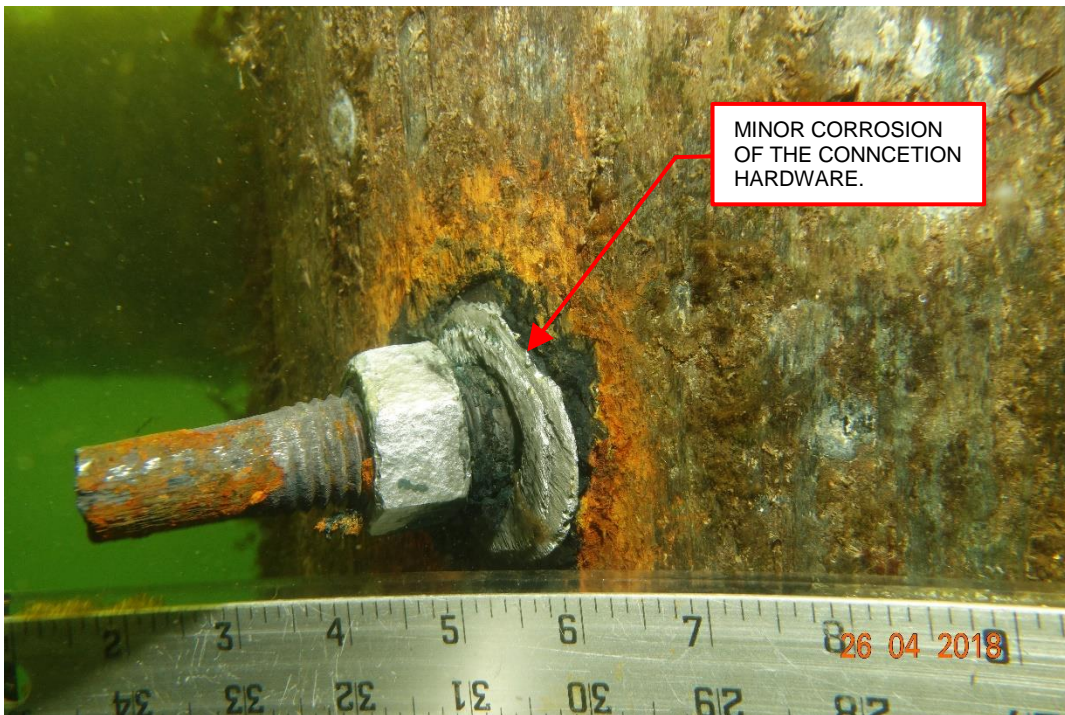
The lower connection hardware below low water was observed to have minor surface corrosion of the connection hardware (See Photo 22). The tops of the timber batter piles typically have marine borer damaged and showed 20% section loss that extends down approximately 1 foot. Marine borer damage was typically found at saw cut joints and counter sunk bolt holes that compromised the timber treatment and did not receive additional field applied protection. Moderate marine borer damage was noted

Photo 22 – Top of timber batter pile connection below water.

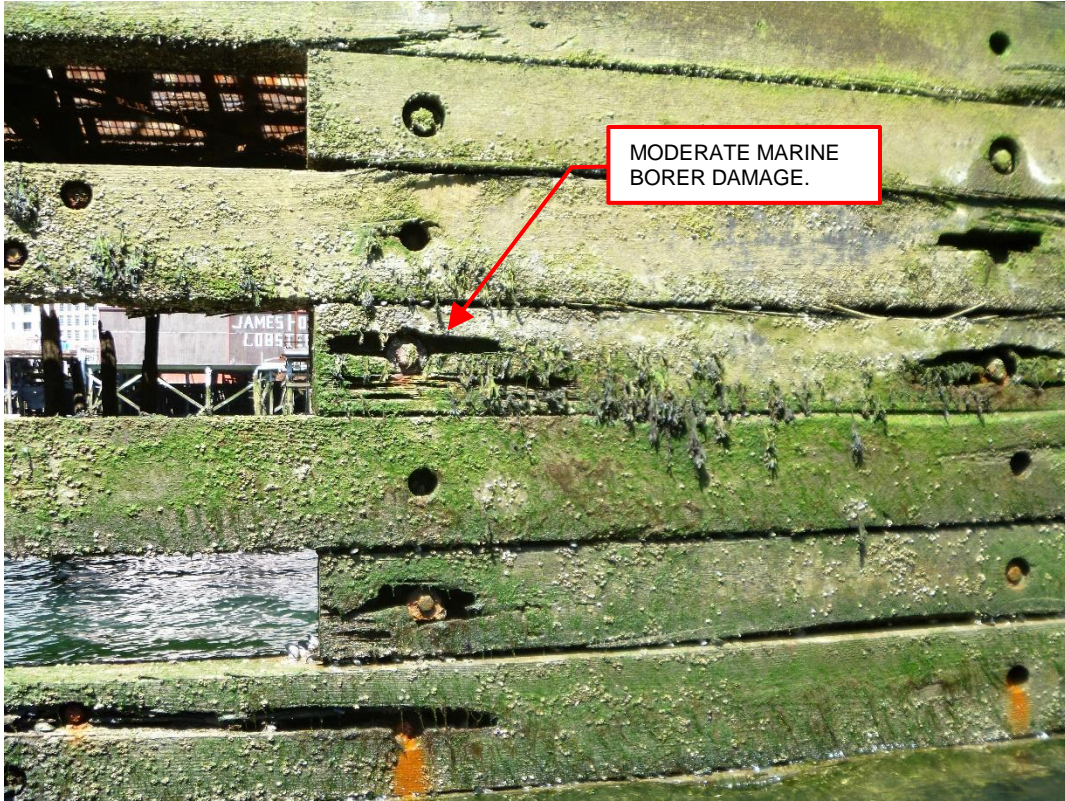
at the countersunk bolt holes for the bottom 4 wales typically (See Photo 23). Damaged areas usually are a void in the wale interior around the bolt head approximately 12 inch long, 3 inch wide, and 3 inch deep (see Photo 24). Isolated missing lower corner timber wale sections, and connection bolts for the timber wales were noted on the West Fender System (See Photo 25). The lower wale connection hardware typically have moderate corrosion and showed 20 to 40% section loss (See Photo 26). Approximately 80 linear feet of timber wale has severe marine borer damage and detached from the fender structure (See Photo 27).

Photo 23 – Typical bottom 4 timber wales for the Fender System.

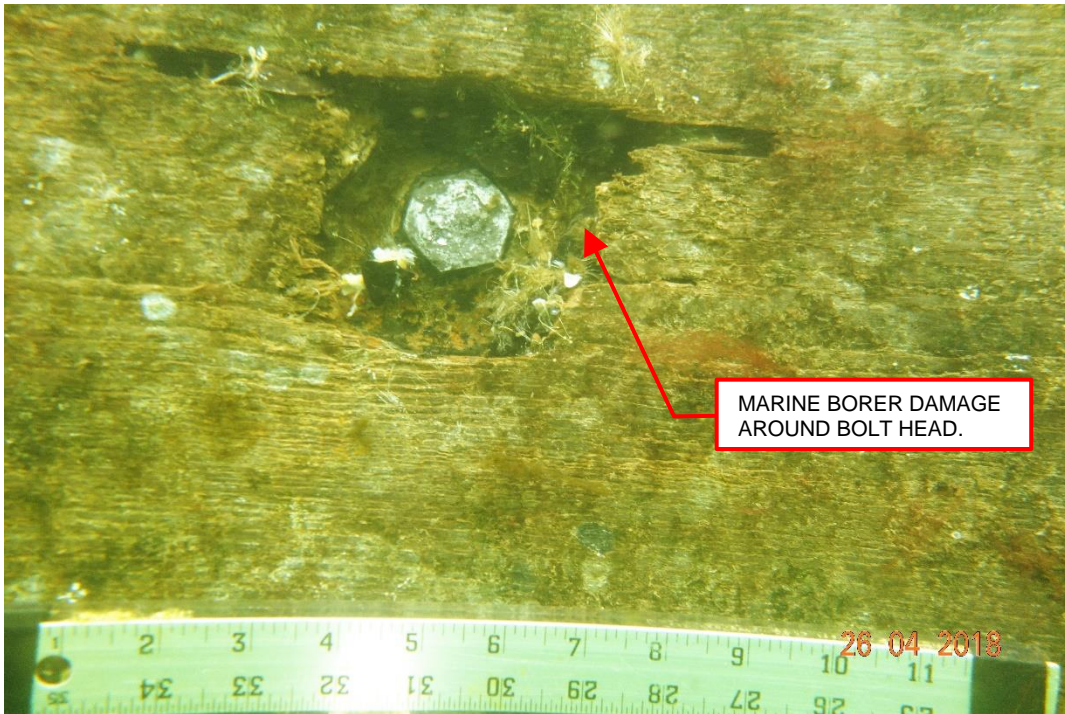
Photo 24 – Typical timber wale connection below water.

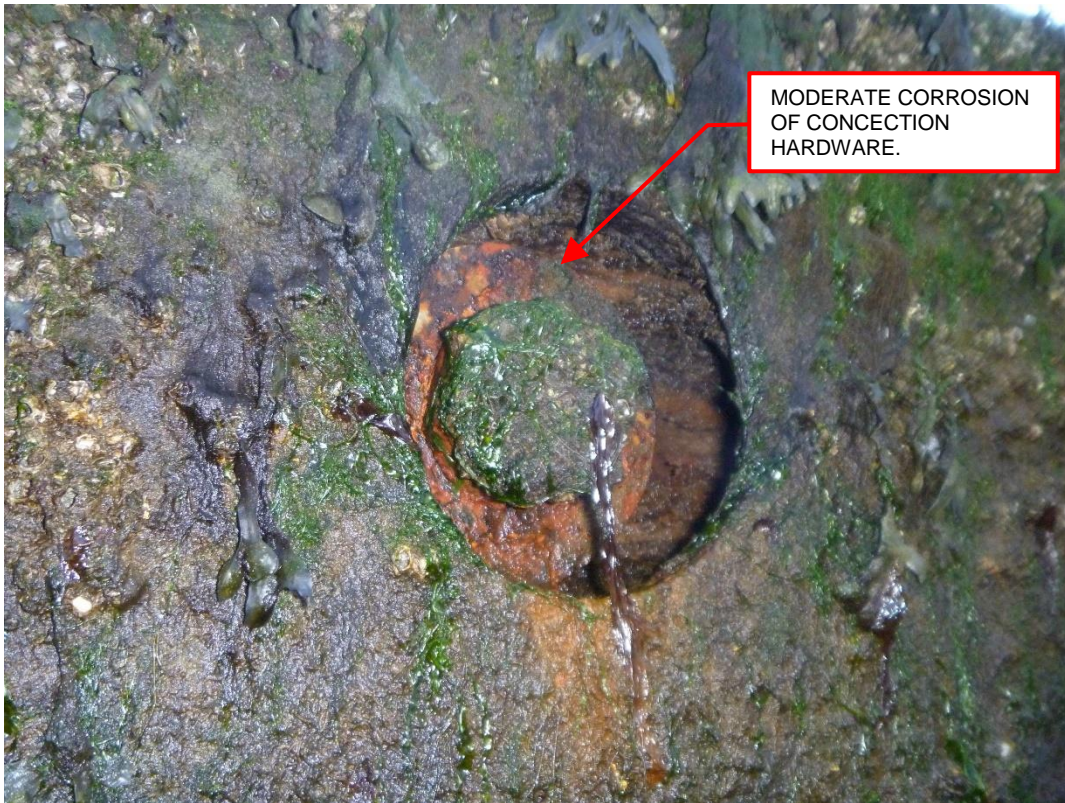
Photo 26 – Typical lower timber wale connection.

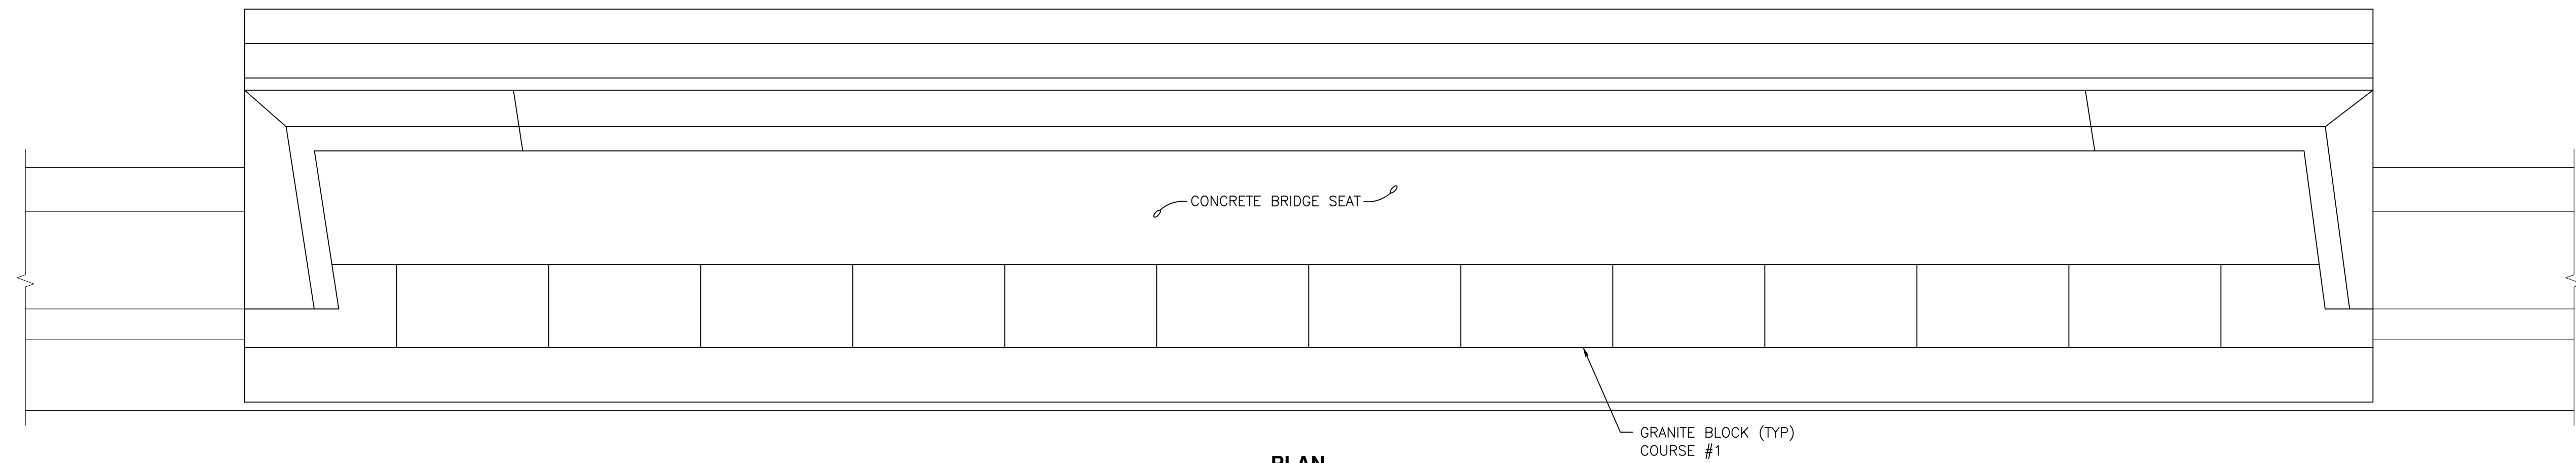
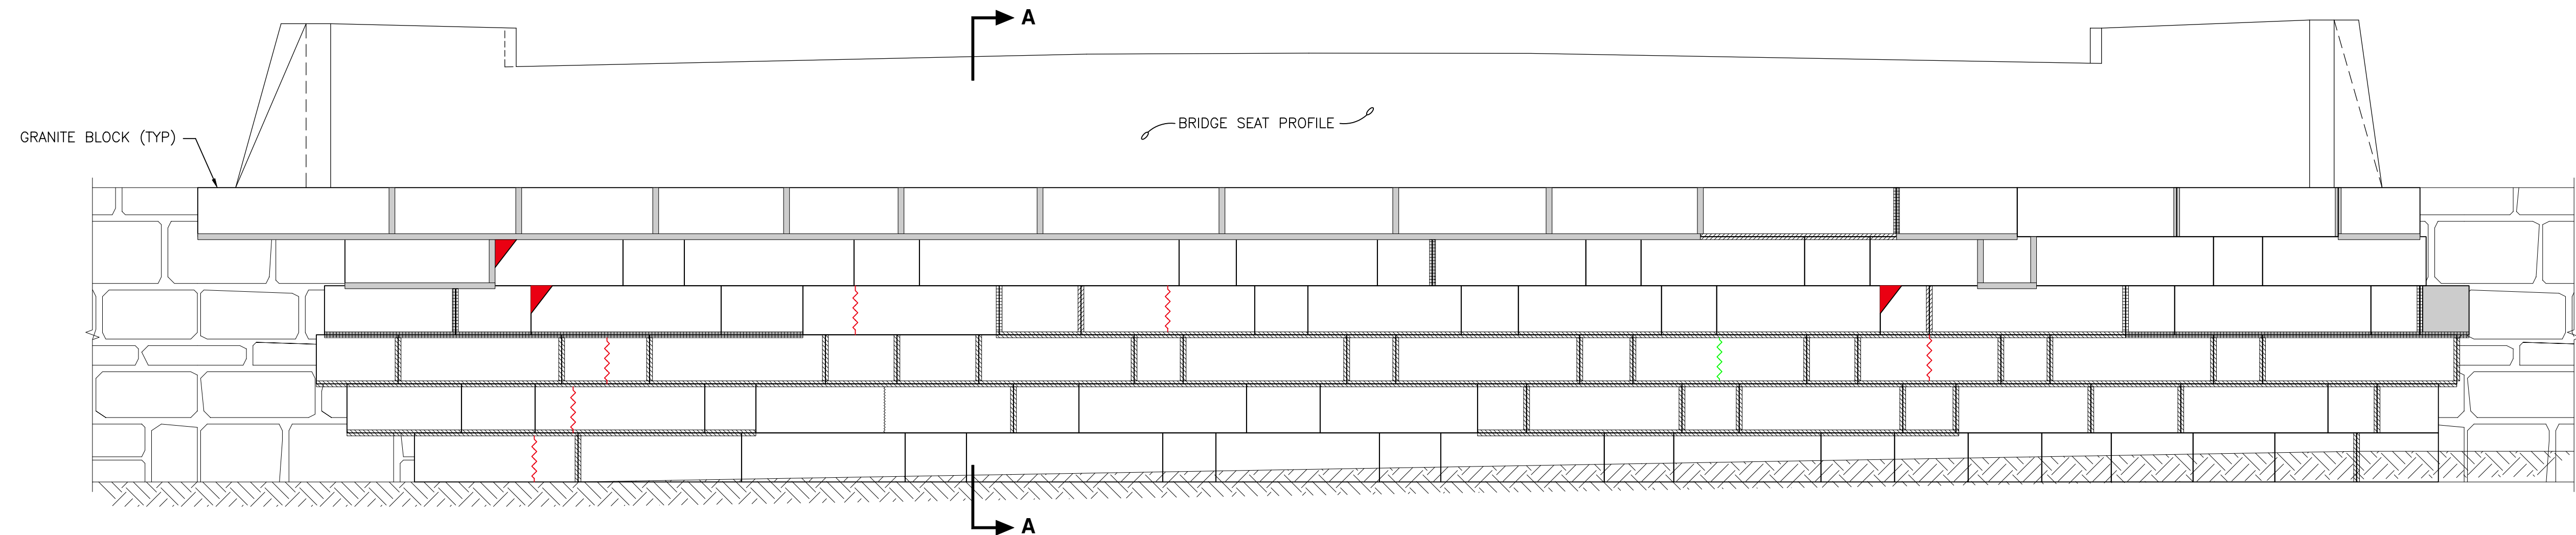
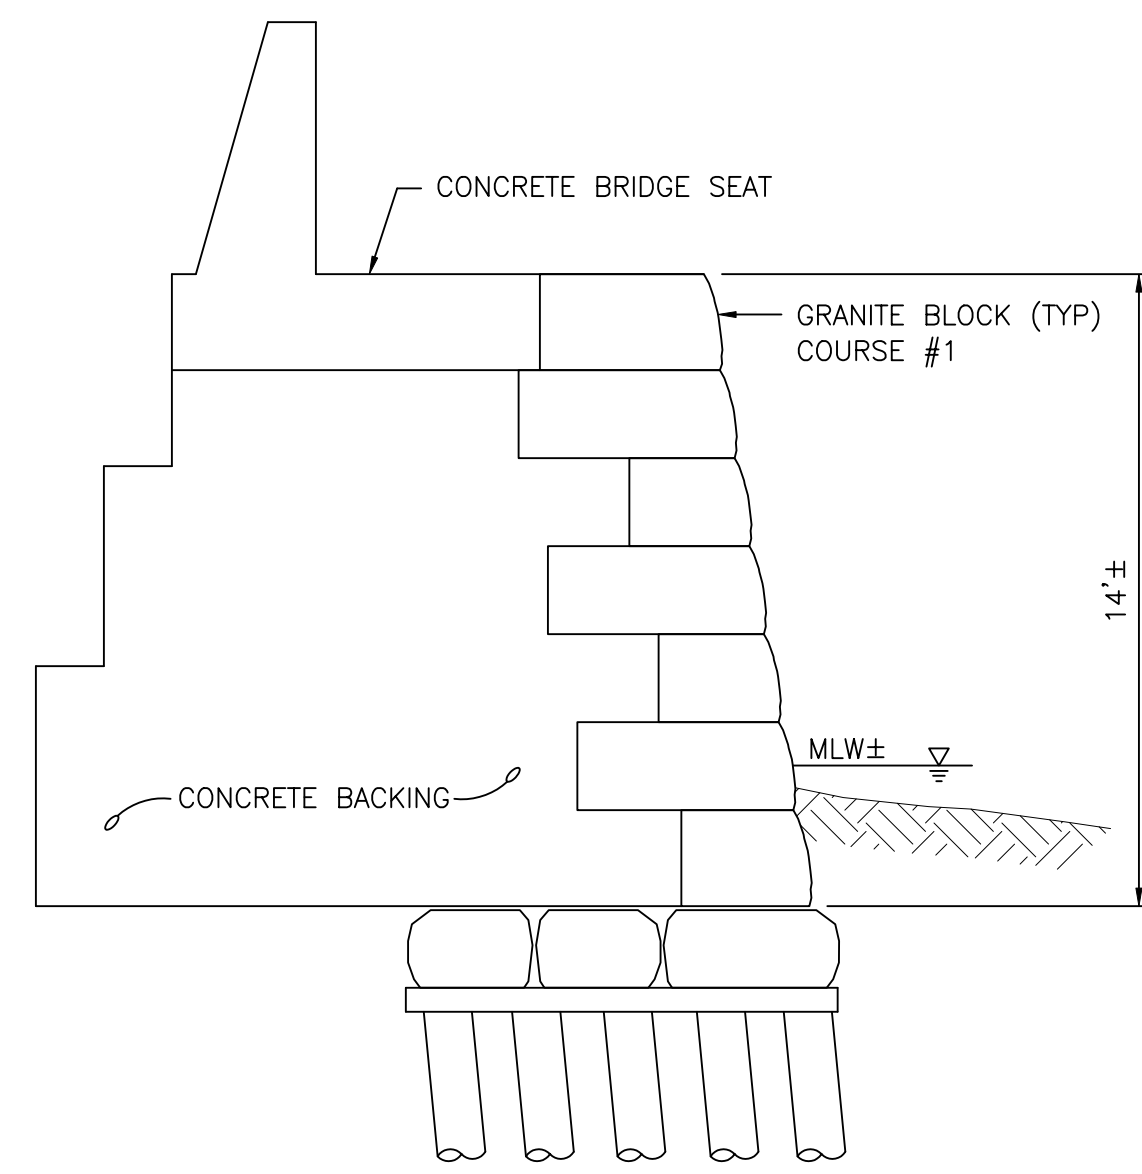
Sheet reference number:
X-09
Sheet 9 of 11

NORTHERN AVENUE BRIDGE
AECOM
BOSTON, MA
**SOUTH BOSTON ABUTMENT
CONDITION PLAN**

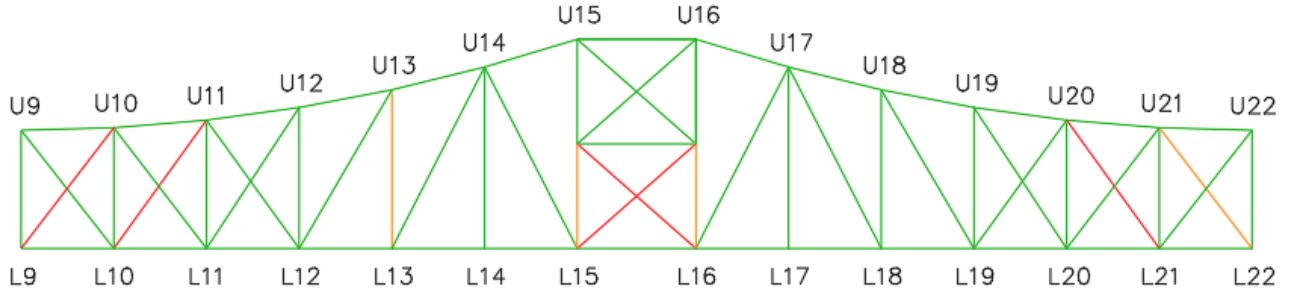
Sketch 16: Swing Span Truss B2N

Select members did not rate for the as-built loading conditions. For the inventory rating condition on the swing span a total of eight diagonals, 4 in the north interior truss and 4 in the south interior truss did not possess sufficient load carrying capacity for all 14 load cases considered as-built. Under the operating condition two members in the exterior truss of the approach span did not rate for the HL-93 Truck loading. The inventory condition resulted in a range of members yielding insufficient capacities depending on the loading condition. These members were primarily located in the exterior trusses. The HL-93 Truck was the main contributor to these conditions, however in select cases, members possessed insufficient capacities for other vehicles as well. Out of the members that did not rate under the as-built inventory conditions, the majority were verticals and diagonals. A full description of these members can be found in *Appendix D*.

If these members were replaced in kind they may rate and have sufficient load carrying capacity. The original steel has a significantly reduced strength compared to today's steel, thus if these same member sizes were re-created with stronger steel it is possible that they would have sufficient capacity for the anticipated loads. However, this will need to be verified during design if the rehabilitation is progressed. Should the members continue to yield insufficient load carrying capacities, even with the stronger materials, then larger cross sections will need to be used.
